# Structural Integrity Assessment on the Sustainability of an LNG Export Terminal

**ABSTRACT** - Natural gas reserves were discovered at offshore of Bintulu, Sarawak in late 1960s. First Liquefied Natural Gas (LNG) project begin operation since 1983. Currently there are nine (9) LNG production trains with an export terminal of three (3) berths in operation. This paper presents structural integrity assessment of an LNG export terminal to ensure sustainability and continuous safe cargo delivery, which was originally intended to operate up to 2021. Extension of service life avoid demolition of existing jetty, minimise construction activities and material used thus reduce CO<sub>2</sub> and waste generation. Various inspection techniques such as visual inspection, underwater inspection, detail inspection with destructive test (DT) and non-destructive test (NDT) were conducted. Detail analysis with StaadPro V8i software was performed to assess the jetty structure integrity at current stage and prediction on safe operation in future. The field inspection results show that 62% of concrete pile jackets experienced moderate to severe defects. Generally, the jetty concrete structure was fou

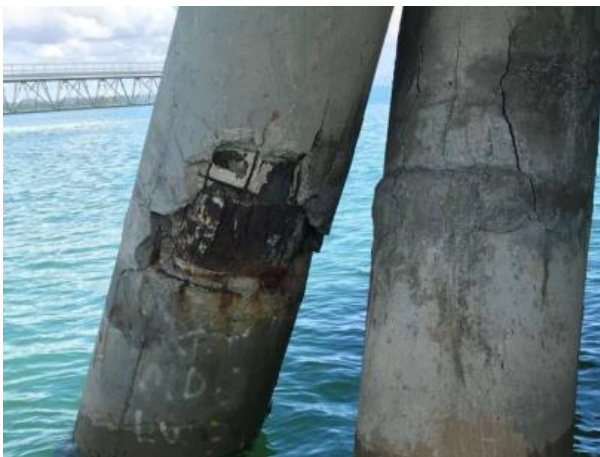
From visual inspection, cracks and spalling were observe on the above water pile concrete jackets. Typical defects of pile concrete jacket are as shown in Figure 6. This is mainly due to prolonged exposure to severe marine conditions with high chloride content in the seawater causing steel reinforcement corrosion. In general, defect is more severe on seaward piles due to direct wave impact. 62% of concrete pile jackets were found with moderate to severe defects that requires rectification. Heavy presence of barnacles and other marine growth can be seen at submerged section as shown in Figure 7.

Figure 6. Major crack and spalling of concrete jacket due to chloride attack of steel reinforcement

- Provide cathodic protection and/or ensleeve of piles below water.
- Repair of jacketing and/or ensleeve of piles above water. Typical concrete jacket sleeve and HDPE sleeve are as shown in Figure 14.
- Repair and rehabilitation of reinforced concrete structure.

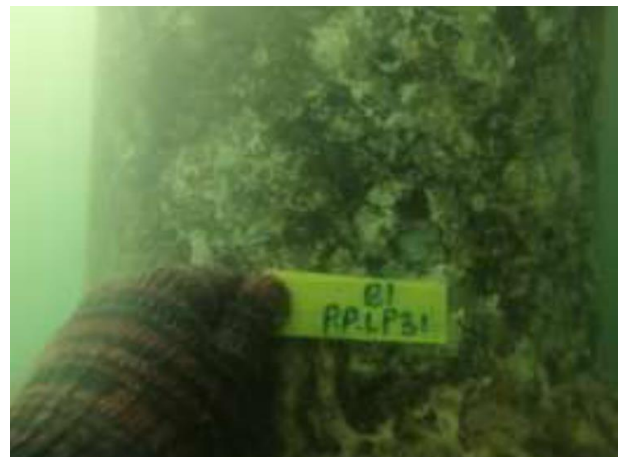
Figure 7. Presence of barnacles at submerged section

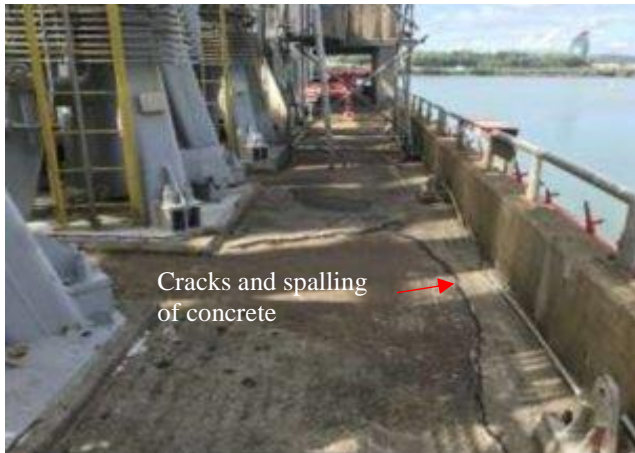
The trestle constructed of inverted 'U' precast concrete panels bolted together and resting on the pile caps. Water marks and stains were observed at about 30% of soffits of the trestle and surface of pile caps. Water was noted to have seeped through the joints of the precast panels and from the discharge holes on some of the precast panels. There were no concrete delamination or spalling found on the under-deck soffits of the trestle. Generally, the concrete structure was found to be still in good condition. Typical defects of concrete structures such cracks and spalling are as shown in Figure 8 and under deck soffit still in good condition as shown in Figure 9.

Figure 8. Minor cracks and spalling of concrete on loading platform

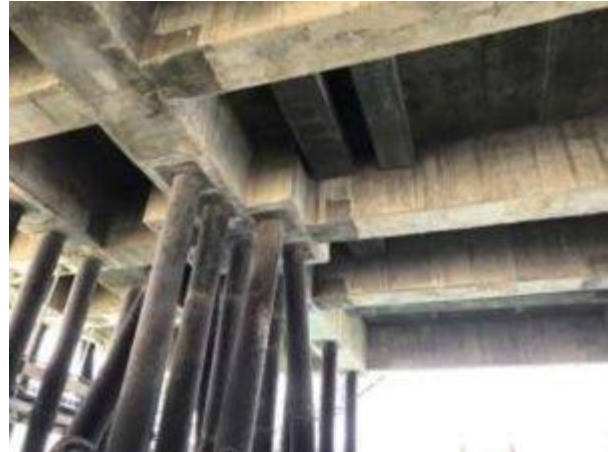
Figure 9. Under deck soffit (good condition)

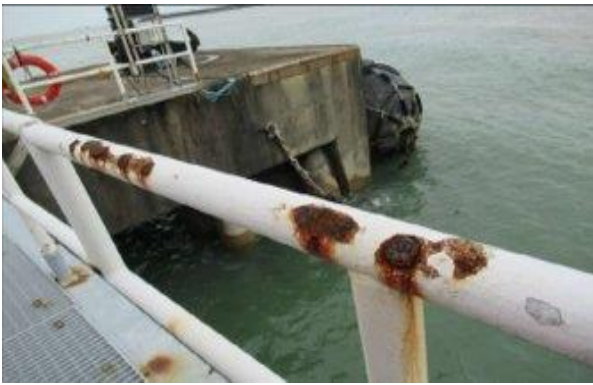
The steel structure inspection for staircases, ladders, catwalks and miscellaneous supports found general corrosion, minor rust stains and surface corrosion which require minor repairs and recoating. Typical surface corrosion defects of handrail are as shown in Figure 10. In general, catwalks are still in good condition is as shown in Figure 11.

Figure 10. Surface corrosion on handrail

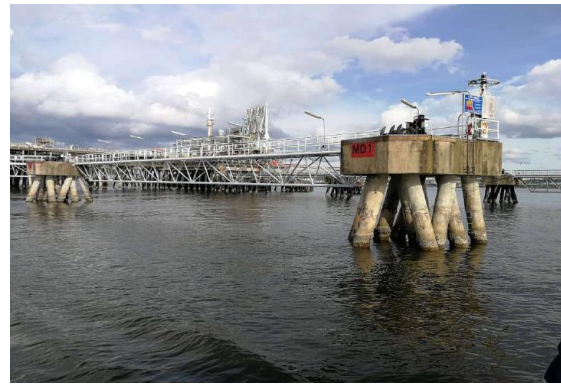
Figure 11. Catwalk between mooring dolphins is still in good condition

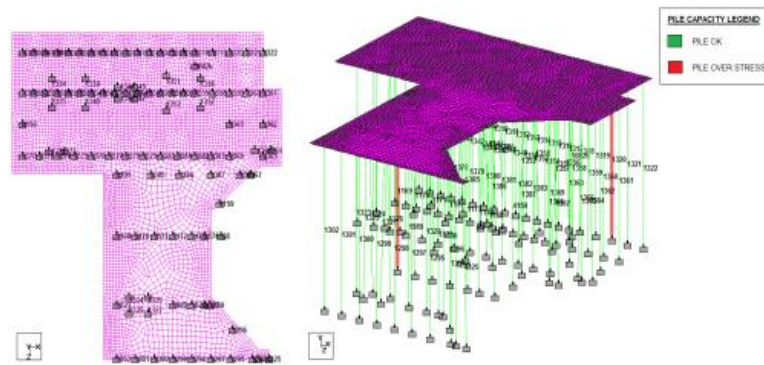
Figure 13. Structural modelling output for loading platform (future-2039)

From the structural analysis with original designed pile thickness of 12.7 mm, the jetty structure can accommodate 80,000 DWT vessel [18,19,20]. However due to reduction in wall thickness over the years, piles at some structures as indicate in Table 6 were found overstress. Further assessment found that there is a need to reduce the designed berthing velocity from 115 mm/s to 100 mm/s for safe berthing of LNG tanker up to 80,000 DWT unless the piles capacity is reinstated.

To address the reduction in pile capacity due to corrosion, mitigation through operational control by reducing berthing speed or major rehabilitation via strengthening of piles to reinstate to its original design capacity have been adopted.
