Development of Proving Ground Field Test for Establishment of Vehicle Accelerated Corrosion Test Procedure in Malaysia

L. Anuar^{1,2}, A. Amrin^{1*}, R. Mohamad¹, S. A. Aziz¹ and M. Toozandehjani¹

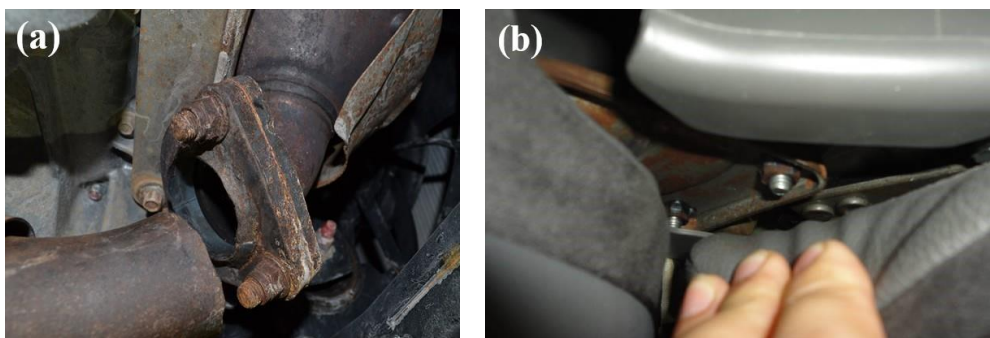
Area	CCR at accelerated corrosion years										Issues
	1	2	3	4	5	6	7	8	9	10	
Underbody	9	7	7	7	6	5	1	1	1	1	Exhaust flange
Underhood	9	7	7	6	5	5	5	4	3	2	Fasteners
Exterior and secondary surfaces	10	10	10	9	9	8	8	8	7	6	Not available
Interior surfaces	10	10	8	8	8	7	7	7	7	6	Seat frame

The exhaust flange was unexpectedly experienced a component failure where a weld detachment occurred as shown in Figure 5(a). The weld detachment failure was considered as loss of function and failed to meet vehicle and component functional use. While, for interior surfaces, at year 10, the seat frame experienced moderate corrosion (CCR 6) as shown in Figure 5(b). Figure 6 shows example of exterior/secondary surfaces that were evaluated during the test. The exterior/secondary surfaces were observed to comply with the requirement of minimum rating 6. However, some obvious corrosion areas was found like bleed of rust on fuel filler lid as shown in Figure 6(c).

Figure 5. (a) Exhaust flange failure and; (b) rusty seat frame.
