Characteristic of Safety Recovery Zone and Roadside Hazard Cases in Malaysia Road: A Review

¹A.K.Kunji, ²A.Kusbiantoro, ²A.Zulkiple and ¹H.M.Ramli

¹Perunding RJA, 25100 Pahang, Malaysia

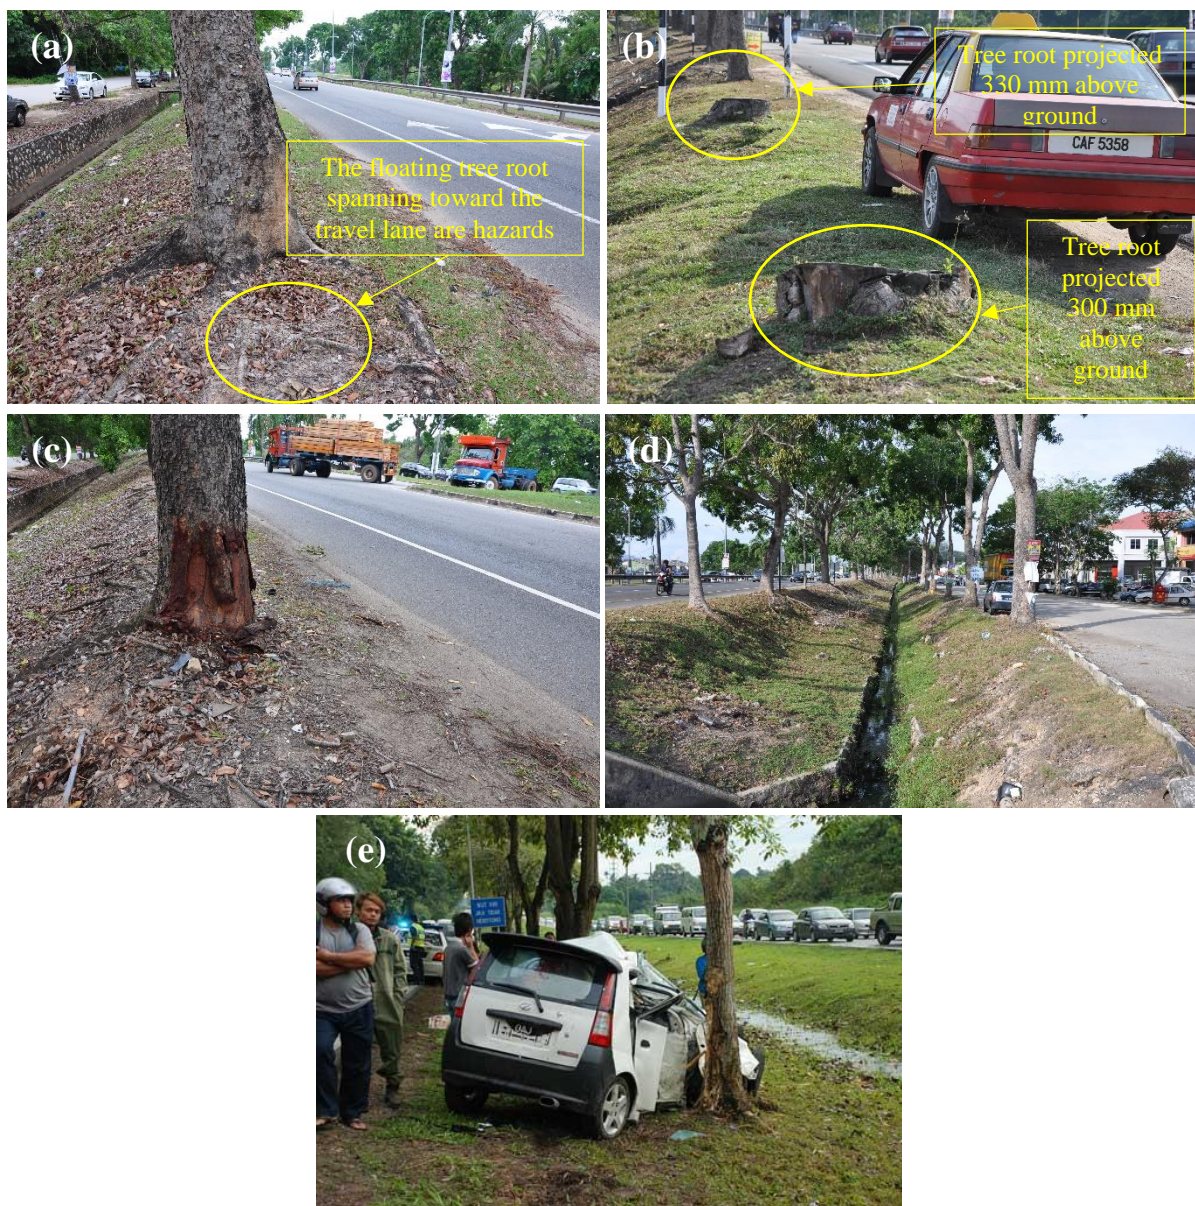
Figure 1: (a) Potential hazard of a tree; (b) Stump of trees; (c) Evidence of damaged tree due to collision; (d) Row of trees along the road near Kuantan; (e) Fatal accident at Bintulu, Sarawak [24].

Figure 1 (a) shows a tree at km 5 Gambang-Kuantan road has stem diameter of 490 mm measured one metre above the ground, the size grew from the original size of less than 100 mm and now has multiplied about 5 times over about 15 years period, the present size is at the state of extremely hazardous object. The tree stem location is about 3.8 meters away from the travel lane, but its effective distance from the travel lane reduces as its root spanning toward the travel lane. The root itself is a hazard, as vehicle especially motorbike will lose control running over it. It is believed that the skinned off part of the tree is the old mark of being hit by vehicle.

Some of the trees planted along the main road have grown up big as shown by the stumps 800 mm and 600 mm as shown behind and in front of the car respectively in Figure 1 (b). The trees were cut but not uprooted, and they remain as hazards to roadside. The tree stumps are hazards as they can cause vehicle to airborne upon colliding and plunge into the nearby drain. It is recommended that all the existing trees spaced at about 12 meters interval along the roadside of the main road to be removed and let alone the sling road trees as shown in Figure 3 remain as required National Landscape Policy for development area in its vision of transforming Malaysia into beautiful garden nation by year 2020 [23].

Figure 1 (c) shows the tree fresh peeled skin at the bottom part of the tree indicates that it was recently hit by a vehicle as evidenced by the broken pieces of the vehicle scattered body parts on the ground nearby the tree. The trees along the main road are hazard to passing by motorists and shall be removed. Meanwhile Figure 1 (d) shows a damaged car after it rammmed a tree, killing the driver on the spot at Kidurung, Bintulu, and Sarawak in August 2012. The tree shown in the figure is having stem diameter of about 250 mm and planted at about 3 m away from the nearest edge of travel lane which is within the Malaysian landscape design guide restricted for planting zone of 9 m roadside corridor for rural road. The earlier grown size was less than 100 mm diameter but overtime it has grown bigger and has become a hazard. Despite the diameter is not really that big, but side collision is more critical compared to front collision due to the thin layer and soft nature of the side door. Head on collision has thicker layer from the front bumper, the engine compartment and the dash board before reaching the driver.

It is recommended that the Malaysian landscape design guide Clause 4.1 which reads as "Clear zones is defined as the area adjacent to the road pavement to the first tree (of diameter greater than 100 mm) planted" shall be rephrased to "Clear zones is defined as the area adjacent to the road pavement to the first tree planted" i.e. with the elimination of the phrase "(of diameter greater than 100 mm)". In addition, to remove the last paragraph under the same section that reads as "Only shrubs and trees of diameter less than 100.00 mm are recommended to be planted within the clear zone". The recommendation is to totally restrict planting of tree within the safety recovery zone corridor.

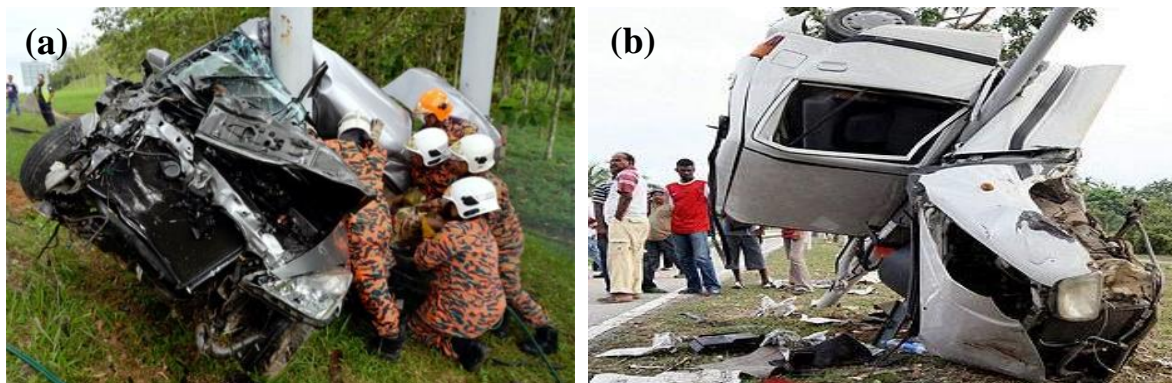
Figure 2 (a) shows a car rammmed into a lighting pole splitting the car into two at Dengkil/Cyberjaya exit. The lighting pole is positioned within the 3 meters road shoulder, a space that is too tight for skidding vehicle to manoeuvre back to the travel lane. The road is under the category of

a primary rural road with speed limit of 110 km/h and traversing on roadside slope less than 1V:10H, based on Table 1, the recommended roadside safety recovery zone corridor width is 5.94 meters. If the lighting pole is installed outside the safety corridor of 5.94 metres, the car could have escaped from hitting the lighting pole. Technically the pole can be placed outside the emergency lane with the upper part of the pole cantilevered over the lane or opt for the spot light kind of design. Utility poles safety issues can be resolved through collaboration of effort between the highway agencies with the respective utility companies.

Figure 2: (a) A car ramped into lighting pole splitting the car into two (b) A car crashed into a road signpost. Source: New Straits Times, May 3, 2013.

Figure 2 (b) shows the car crashed into signboard pillar causing five in family killed on 02 May 2013 at North–South Expressway, Kulai Jaya, Johor. The pillar shall be kept away from the travel lane as far as the width of safety recovery zone corridor. Based on the study outcome shown in Table 1, for rural expressway travelling speed of 110 km/h and roadside slope of 1V:4H, the required free of obstruction corridor width is 8.07 meters compared to the signboard post nearest position of 6 meters. If the safety zone corridor size were applied, the car would have escaped the accident. However, the grass within the corridor must be cut to ensure it does not sway the car. The signboard can be designed with single instead of double posts with display board projected away or cantilevered from the pole as typically adopted by many traffic lights. The least effort is adapting to shielding the post if fall within a danger zone.

For future and existing roads, where providing roadside safety recovery zone are not practicable, shield the pole to reduce the potential impact from vehicle collision. It is recommended that the design guide clause 6.3 be added with statement that “all lighting poles and post to be placed outside the safety recovery zone, and if limitation arise, they are to be shielded to minimise collision impact”. Sign and luminaire are typical highway accessories, placing them wisely may save some lives. Having them installed too near to the roadway, they will become obstruction and open to collision Sign and luminaire supports to be relocated at least possible crash areas. Power and telephone cables can be buried to overcome from becoming obstacles.

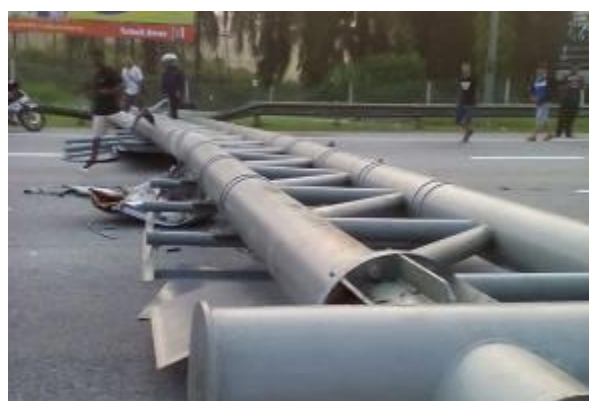
Figure 3: A signboard girder collapsed onto a passing car

Figure 3 shows a metal signboard girder collapsed onto a passing car after a trailer crashed into its post causing 3 in the family died on 10 October 2015 at km 399.8 Tg. Malim/Behrang, North-South highway. The girder was supported on metal pole with the nearer to travel lane pole positioned at about 5 meters from against the study recommended spacing of 6.89 meters for road speed limit having roadside slope

of 1V:6H as in Table 1. If the study recommended spacing is applied, the vehicle might escaped from hitting the steel column and save the motorists life.

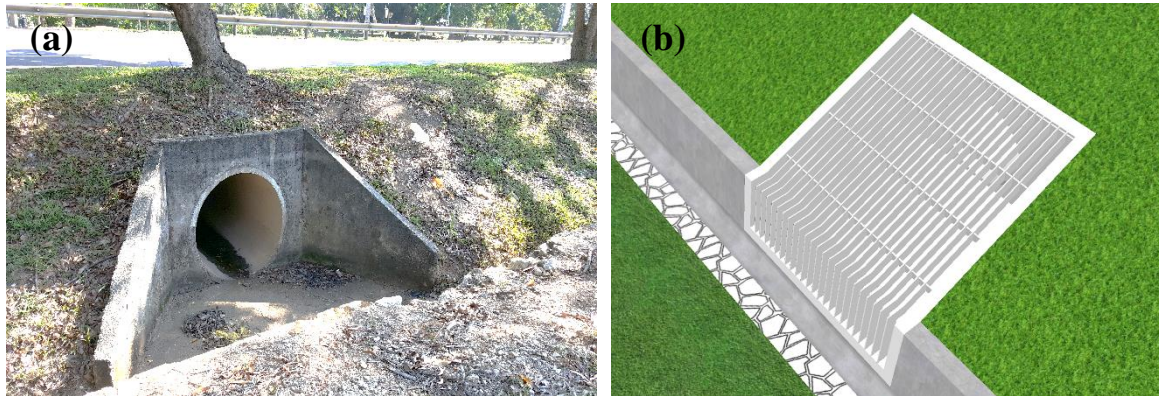
Most of the culverts in Malaysia are having inlet and outlet without metal grating cover as shown in Figure 4 (a). The projection of the concrete head and wing walls above ground surface may cause vehicle to be airborne upon striking. In building-up inlet and outlet as a traversable fore-slope, all culverts inlets and outlets shall be designed to intercept with the roadways embankments and flushed with metal gratings [3, 27].

Figure 4: (a) Concrete culvert at km 5 Gambang-Kuantan highway; (b) Proposed modification to the culvert for (a).

It is proposed that the existing culvert inlet and outlet head walls constructed within the roadside safety recovery zone corridor, the wing wall to be modified as shown in Figure 4 (b). The metal screen serves two functions, namely for screening the debris and the surface is traversable by skidding vehicle for in an attempt to recover back to the travel lane. The metal blade is set to be vertical to minimise debris clinging to the grill and affecting the proper flow of the discharge. As shown in the detail, the selected design is 12 mm plate thickness spaced at 100 mm centres. Both wing walls are set straight instead of at an angle with the direction of storm water flow to prevent entry of eroded earth into the culvert.

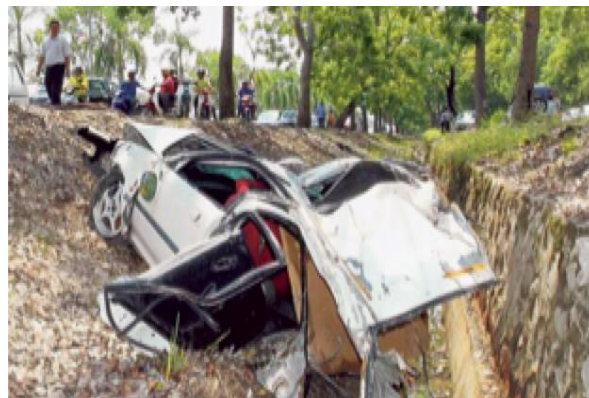
Figure 5 shows skidded car where the driver could not control the car due to steep roadside slope of 1V:1H against the good design practise of 1V:4H the limit for traversable slope and hitting the drain's hard rubble pitching wall and bounced back causing three passengers died and one badly injured. Should the one sided rubble line wall was replaced with turfed earth, the downslope 1V:1H embankment was built with the study recommended new slope of 1V:4H, even if skidded, there was a possibility the passengers may survived from death and suffered injuries only.

Figure 5: Fatal Accident at Roadside Drain (Source: Kosmo, 10 December 2015)

If the roadside tree and the drain were positioned outside the study recommended safety recovery corridor, the passengers may survive both deaths and injuries. The tragedy has given evident that the drain design is not forgiving and need to be reconstructed with a new design. It is recommended that the drain to be reconstructed with a new design by applying the design concept recommended by the Malaysian standard as shown in Figure 8 (a). The redesign cross-section with enhanced safety of the highway and the sling road are shown in Figure 6 (a) and (b). The discharge capacity of swale is the combination of on the surface capacity, the perforated conduit volume and the interstices of sand and gravel. The volume of runoff to be served is minimal i.e. it is between the centre lines of the highway and sling roads about 20 meters width.

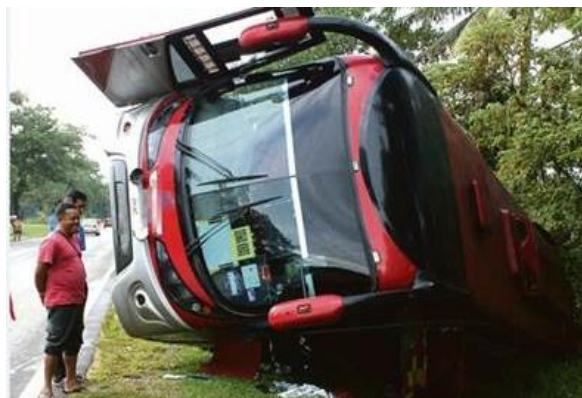
Figure 7, shows a bus skidded into roadside drain located at less than 2 meters away from the travel lane. The bus was avoiding collision from the oncoming car encroaching its lane, but unfortunately the roadside drain is too near to travel lane causing the bus has no space for traversing back to the carriageway. The tragedy evident that all drain to be built away from safety recovery zone corridor in order to ensure motorists safety. If placing drain outside safety corridor zone is unavoidable, the chosen type of drain shall be of traversable type, similar to the previous case employing swale design concept as shown in Figure 8 (a) The similar drain if located at the back-slope, apply cross-sectional design shown Figure 8 (b).

Figure 7: A bus flip over at roadside drain (Source: Ammboi, 20 October 2013)

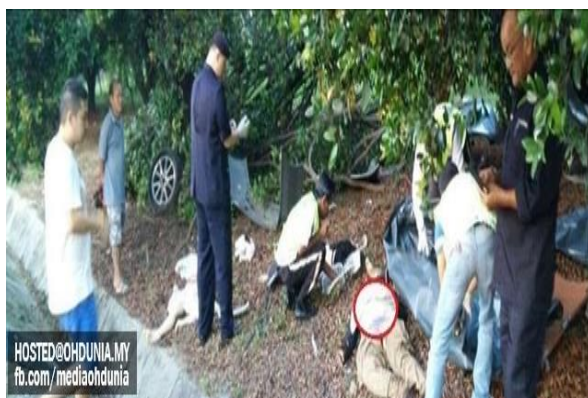
Poorly designed kerbs causing damages upon collision to tyre sidewalls, wheel alignment, sometimes burst and may lead to fatal accidents on prolonged usage. Straying off from travel lane, wheel contact with kerbs could cause a vehicle to airborne and overturn. The ‘forgiving’ type kerb known as ‘mountable kerb’ is one of the two classes of kerbs recommended for application in design by the Malaysian standard known as *A Guide on Geometric Design of Roads* issued by the Road Engineering Association of Malaysia (REAM) under section 5.4.2 [25]. The other type of kerb recommended by the design standard is known as ‘barrier kerb’, though appear to be small in size but the force on impact with the concrete block may cause fatal accident as in the case shown in Figure 9, the motorcar hit the kerb then airborne killed 4 at kilometer 9.9 Elite highway Subang Jaya. The section 5.4.2 prohibits the use of barrier kerb for expressways or design speeds exceed 70 km/h, and the recommended use in build-up areas adjacent to footpaths with considerable pedestrian traffic. If mountable kerb is applied, the motorcar will rise over the kerb, dissipate part of the impact energy and the subsequent reduced

impact energy on the roadside may not be fatal but with injuries. In enhancing the road safety campaign, auditing and correcting nationwide roadside kerb can be added to the agenda.

Figure 9: Fatal accident of a motorcar after hit a kerb. (Source: Ohdunia, 26 July 2015)

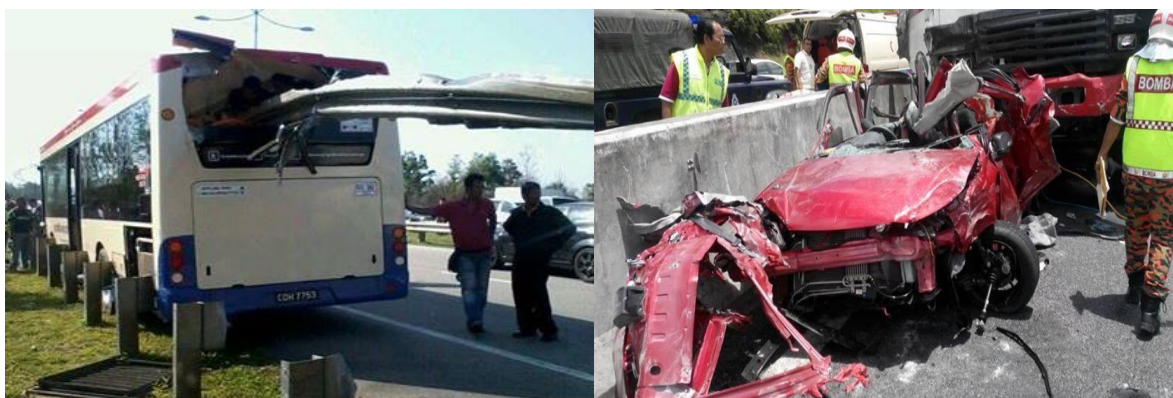
The guardrail itself can be a roadside hazard as shown in Figure 10 (a), an accident at kilometre 13 Jalan Kuantan-Pekan, where the bus front left tyre exploded and then stroked into roadside longitudinal safety barrier has caused the metal beam punctured through the bus [30]. One passenger leg was broken and two passengers were with minor injuries. The reduced risk factor is due to the high elevation of the bus as compared to that of safety barrier height. The safety barrier installed was to shield the row of trees planted within the clear zone of 6 meters. Based on the guidelines, the trees are not permissible to be within the clear zone, and the instruction is a safety barrier is to be provided when the trees cannot be removed or relocated. In this case, the trees to be relocated at the offset of 6 meters from the travel lane due to available, otherwise the trees to be removed.

Figure 10: A metal beam punctured through the Rapid Kuantan Bus; (b) A car crashed into concrete wall
(Source: Melvister, 4 October 2014)

Figure 10 (b) shows a car crashed into concrete wall and caused two people died from the family at km 256 PLUS highway. The barrier is of the rigid type and its function is to redirect the vehicle upon collision where the dissipated energy will be absorbed by the vehicle and causing the metal body to deform, and sometime lead to fatal accident. It is recommended quay fender be lined to the side of concrete barrier wall at accident prone location as shown in Figure 11.
