## Rehabilitation of Sunkoshi Small Hydropower Plant (2.6 MK), Nepal after Sequences of Natural Disaster

*Sakunda Ojha*

*Sanima Hydropower Ltd, Dhumbarai, Kathmandu, Nepal*  
*\*Email: [sakunda@sanimahydro.com](mailto:sakunda@sanimahydro.com)*

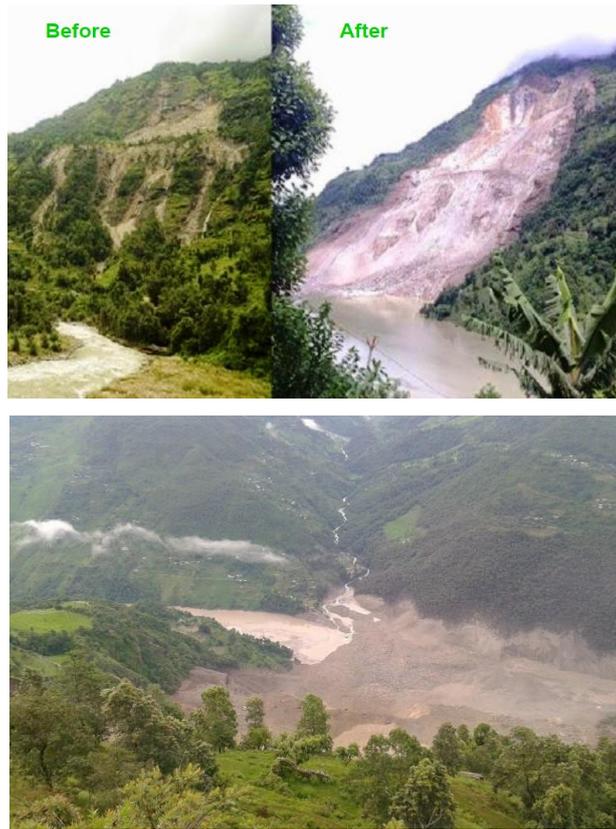
**Figure 1:** Jure Landslide

A massive landslide was triggered at around 02.30 am, local time on Saturday, 2 August 2014 at Jure village in Sindhupalchowk district in the boarder of Mankha VDC-01 and Ramche VDC-04. The landslide blocked Sunkoshi River creating a high dam of about 55 m across the river. The back flow water from this entered Sunkoshi Hydropower Station at about 8:05 am and fully sub-merged the powerhouse at about 2:30 pm. The water level was maintained at about 840 amsl (which is above the roof level of powerhouse).

The landslip comprising huge detached rock mass blocked the river forming a natural dam. The estimated total volume of material in the natural dam was about 60,000,000 m<sup>3</sup>. Landslide material formed very low angle about 15 to 20 degrees along upstream and downstream. Since, the dam material comprised of shattered rock mass (detached blocks and boulders comprising phyllite and quartzite) covered by cohesive material; the river water could not erode the material. Subsequently, the flow retained into natural lake, pooling about 3.5 km stretch upstream and reserving about seven million cubic meters of water.

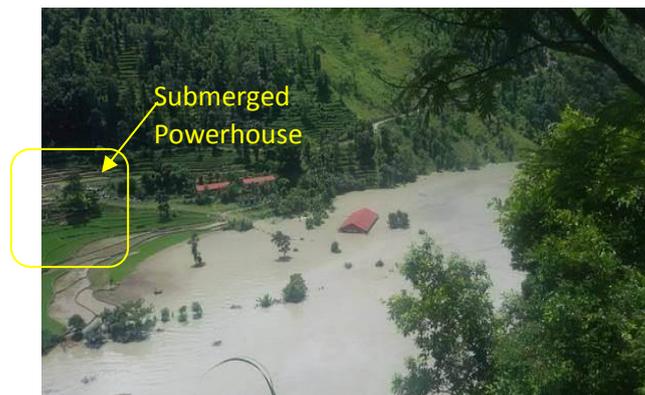
**Figure 2:** Submergence of Powerhouse

The landslide dam abruptly breached on 7<sup>th</sup> of September 2014 at about 2:35 am resulting significant draw down in water level allowing most of the water to drain out. The water level draw observed at Sunkoshi Small Hydropower Plant was from 840 m (as of 19<sup>th</sup> august 2014) to 818 m. The breach appeared to be natural - a response to heavy rainfall, however widening and excavation of channel on downstream from Nepal Army and erosion from rainfall further enhanced the dam breach. The flash flood was observed on downstream due to sudden breach of dam but no significant damage and casualties were found due to this flash flood except damages on dam, undersluice and intake of Sunkoshi Hydropower Plant (NEA) – a downstream 10 MW plant. The power plant was submerged for 36 days starting from 2nd of August to 7th of September 2014.

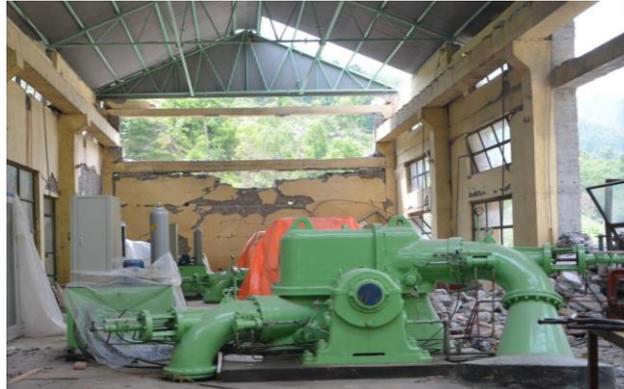
**Figure 3:** Powerhouse floor after earthquake

A 7.8 magnitude earthquake stroke Nepal on 25 April 2015 at 11:56 am creating a large-scale damage and many casualties. The epicentre was located at 81 km northwest from Kathmandu on Barpak of Gorkha District. Hundreds of thousands of households were destroyed rendering people homeless with entire village and settlement flattened. Strong aftershocks, including a 6.6 magnitude on April 26, 2015 and a 6.7 magnitude on May 16, 2015 created more chaotic situation leading further damages to the weakened structures and increase in number of casualties. The first aftershocks of 6.7 magnitudes and hundreds of tremors greater than 4.0 magnitudes caused considerable damages to Sunkoshi Small Hydropower Plant.

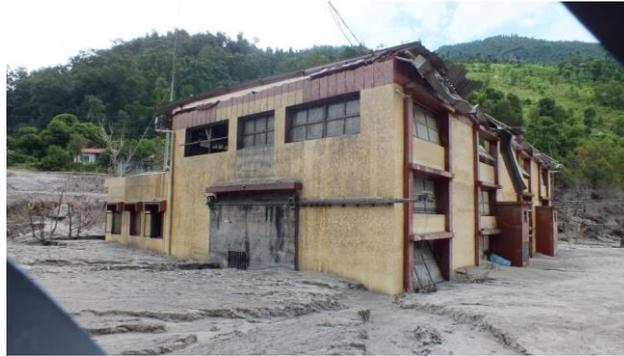
**Figure 4:** Views of damaged powerhouse

- ✓ The powerhouse and its periphery was deposited with debris (sand) ranging from 1.5m to 2.9m depth
- ✓ The Guard post was also partially buried with silt deposition.

- ✓ Areas around transformers were damp, saturated and filled by silt.
- ✓ Cracks were observed on the walls of powerhouse.
- ✓ The transformer outside the powerhouse was partially buried by siltation.

- ✓ About 65m of penstock after bifurcation was buried by silts.
- ✓ Machines (generator, turbines, governors, gates) were buried under Sand/Silt deposition.

- ✓ Sand/Silt deposition depth inside powerhouse were; Machine hall: about 1.5m to 3.0 m, Service transformer room: about 1 m, Excitation transformer room: 1m, Breaker room: 1.5m, Control room: 1m. Few cracks were observed on machine hall's walls.

- ✓ Trusses, purling, CGI sheet and other roofing elements had completely collapsed, damaged and unusable.
- ✓ About 0.7m to 1.2m of silt/sand was deposited on top of control room slab and toilet slab.

- ✓ The panel boards, cable and other electrical items were damaged.
- ✓ The crane inside the powerhouse was damaged.

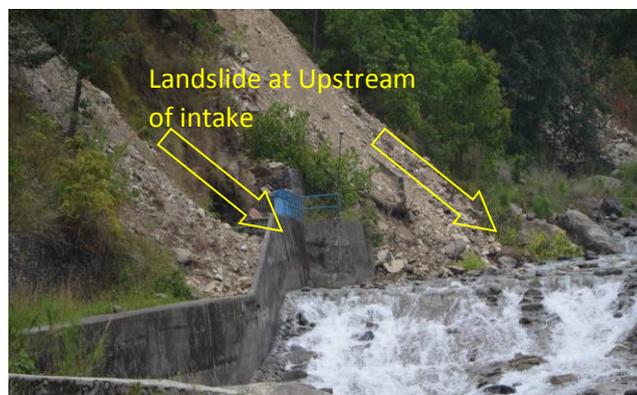
**Figure 6:** Landslide near intake

- ✓ Landslide on immediate upstream and downstream of intake gate area (Right Bank).

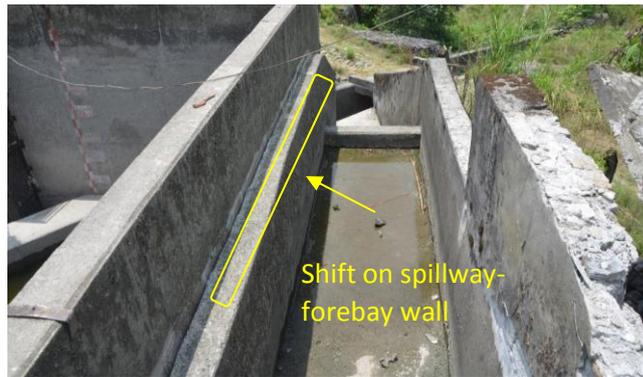
**Figure 7:** Shift of spillway-forebay wall

- ✓ There was a small split (2 cm) on spillway arrangement wall and forebay wall.

Gravel material of size 5 mm to 10 mm was used to fill the gap of spillway area. Thermo coal packing and sealant were applied to the outer exposed part in order to seal the seepage.

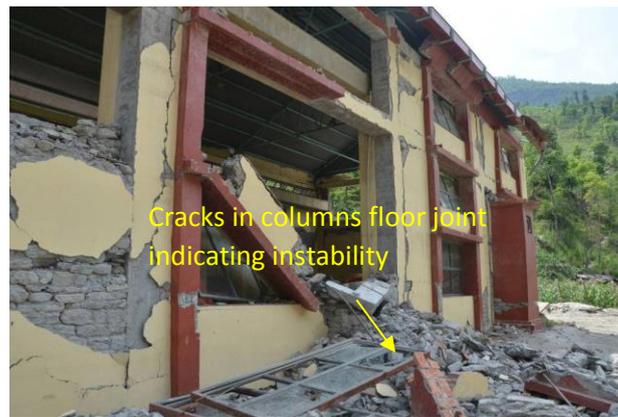
**Figure 8:** Wall Collapse on Riverside

- ✓ Most of the powerhouse wall including lintels and ties had collapsed.

Most of the powerhouse walls including the interior partition wall were damaged due to earthquake. Weak wall were manually dismantled to reduce the probable risks. Later, CGI sheeting was done to fence the outer wall. The interior walls were limited to a height of about 1.5 m.

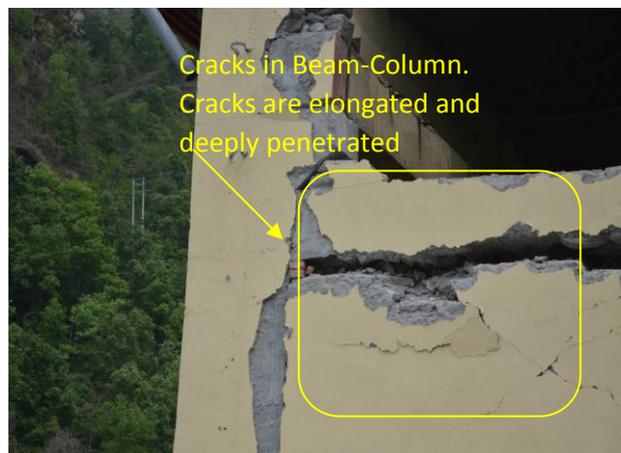
**Figure 9:** Crack on Beam - Column

- ✓ Vertical cracks were observed on edges of the tie beam along northern and southern side of powerhouse. These cracks were developed throughout the depth of the beam.
- ✓ Significant concrete cracks were observed along with deformed bar observed on all hillside columns at corbel level (about 7-8cm crack width).
- ✓ Cracks were observed on riverside beam- column connection.

- ✓ Cracks were observed on the bottom part of column. Prominent cracks were visible on all riverside columns (about 20-30cm above machine floor level).
- ✓ Damages were seen at the excitation transformer and service transformer due to falling of wall.
- ✓ Some cracks were observed on machine floor.
- ✓ The partition walls on control room, breaker room, service transformer room and store room were completely damaged.
- ✓ Toilet roof slab and wall had completely grounded.
- ✓ Shift on transformer was observed (~5cm) however the foundation was intact.

After the Jure landslide, debris deposited around and inside the powerhouse was removed. Damaged roof truss, roof sheeting and gutter were completely changed. Damaged electromechanical parts and machinery were replaced. Powerhouse was further damaged due to major earthquake of 26 April 2015 and 16 May 2015. The damaged columns were initially injected with epoxy grout to fill up the voids developed on the cracks. Later, a jacket concrete section of 150 mm with additional steel lining were provisioned as a retrofitting measure. On the damaged columns of hillside, for the damages just above the corbel level, an ISMB 200 was arranged on each column.

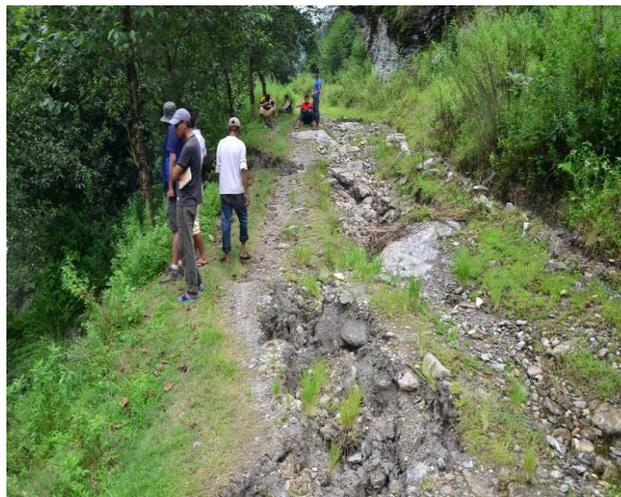
**Figure 10:** Crack on Beam - Column

A new landslide was observed about 15m downstream from Thulodhunga area (located 220 m to 420 m downstream from settling basin along penstock alignment). A wide open crack (about 50 to 75 cm wide) was observed along the road alignment. About 2 m of slope had plunged towards the river. The landslide was triggered due to sudden rise in Sunkoshi River due to flash flood which resulted in toe cutting. In addition, high precipitation caused saturation of soil and loss of shear strength. Stone masonry wall beside the road and plum concrete wall at the toe had collapsed. Pool of boulders were observed about 20m upstream from the toe of the landslide which will behave as spur and protect the exact downhill of Thulodhunga.

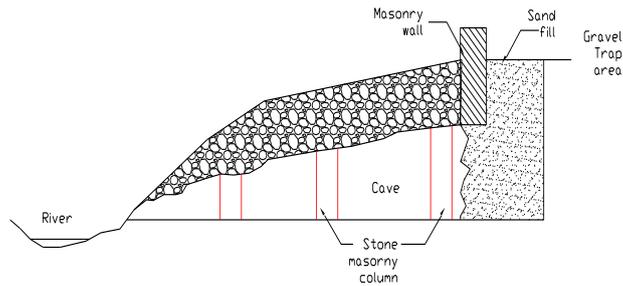
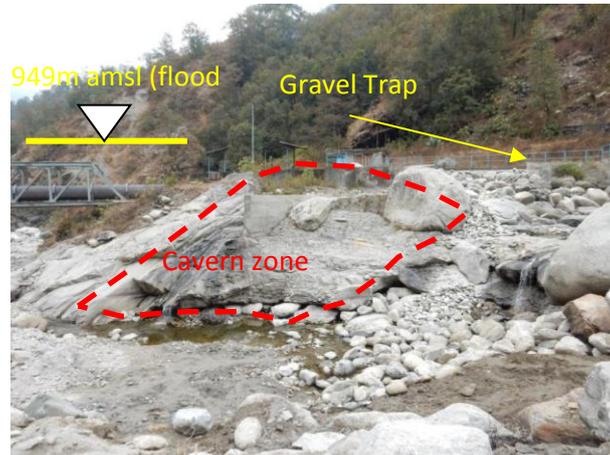
**Figure 13:** Cavern formed near Gravel Trap

After the flow was diverted to the intake, a big cavern was observed under the gravel trap area. The possible cause of the formation of this cavern could be the flash flood that occurred during 2<sup>nd</sup> week of August 2015. The flood level had reached an elevation above 949 m. Due to high energy gradient available during the flash flood, the larger boulders (1-1.5m dia) in the surface dislocated and the packing stones of the core washed away. This has caused formation of a hanging structure which measures about 10 m width and about 15m in length. The approximate volume of the cavern was 56.6m<sup>3</sup>. Following were the remedial measures adopted:

Since the cavern was hanging, there was high chance of its crumbling. For safety, a stone masonry wall (1:4) 0.60m wide X 0.6m breadth was constructed to support the hanging cave. The inner side of the cave was packed with dry stone in layers. Flat shape stones was used and round stones were shaped to give rough rectangular face. This reduced chances of rolling of stones. Plum concreting was done in the outer face of cavern (about 1m from face of cavern). The pool outside of the cave was filled with at least 2m boulders using excavators

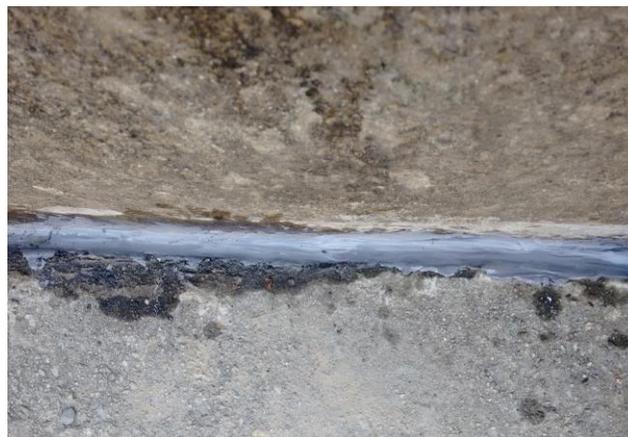
**Figure 14:** Application of sealant between forebay and spillway

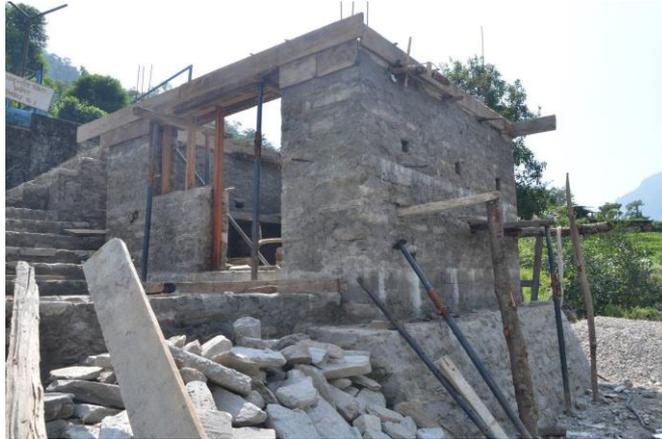
**Figure 15:** Forebay operator's post – under construction

Since the forebay operator post was totally damaged due to earthquake, a new operator post was constructed. It comprises a single room at ground floor and operator view point at first floor. A toilet was constructed just beside the post.

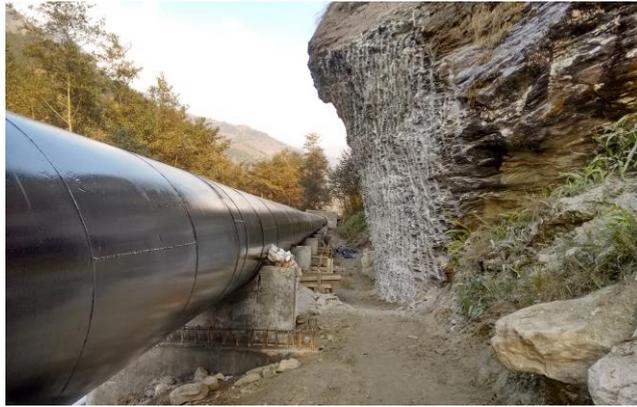
**Figure 17:** Big boulder after trimming

The movement of big boulder located in sinking zone (located 220 m to 420 m downstream from settling basin along penstock alignment) had ruptured the GRP. The damaged GRP section was replaced with mild steel penstock pipe. About 1 m of big boulder was trimmed using Crackamite.

The damaged section of GRP from Ch 0+238.944 m to Ch 0+ 410.223 m has been replaced with 175.83 m mild steel pipe. The new alignment consists of 4 anchor blocks and 29 saddle supports. Two of the anchor blocks are buried and remaining two are exposed to surface. Out of total 25 saddle supports, 9 are free movable type to compensate the probable land movement and remaining 20 are of normal type. About 44 tons of pipes was consumed in order to reinstate the waterways. The replaced pipe consists of single expansion joint at anchor block 2 and 4 bends at each anchor block.

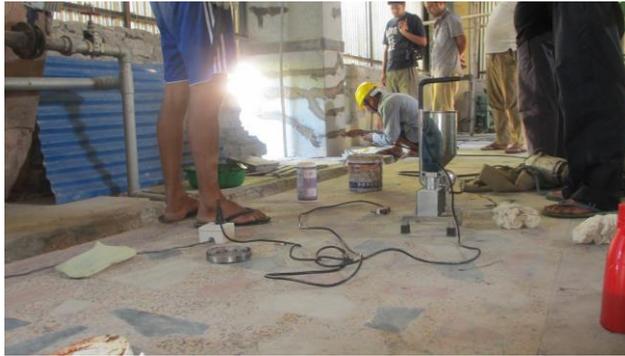
**Figure 21:** Grouting work epoxy mortar to fill the crack before injection of grout) on powerhouse

This technique has been used to fill up the cracks/micro cracks observed in RCC structure due to earthquake.
