## Failure Analysis of Industrial Discharge Hopper Pipe

**ABSTRACT** – This work presents the detailed investigation and root cause analysis of catastrophic failure of an industrial discharge hopper pipe. The hopper pipe investigated in the present work is made of austenitic stainless steel, 316 grade, a commonly used grade for valves, pipes and heat exchanger tubes. The pipe fractured in transverse direction, leading to the failure of discharge pipe. Visual inspection, dye penetrant test, chemical analysis, microstructural analysis, and fractography analysis were carried out on the failed part and it was concluded that stress corrosion cracking led to the failure of hopper pipe. The pipe constantly being under the exposure of industrial water and the presence of chlorine content in it made it susceptible for stress corrosion cracking. Transgranular fracture was clearly observed in the microstructure of failed sample and spot EDX at the fracture location confirmed the presence of chlorine content. Further, fractography showed striations indicating fatigue loading. The work concluded that stress corrosion cracking as the root cause of failure.

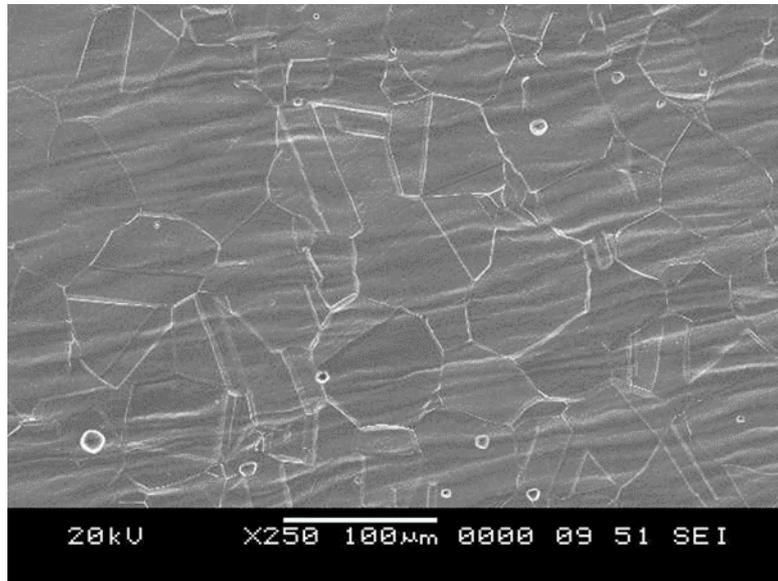
The hopper pipe was made of 316 grade austenitic stainless steel, a commonly used stainless steel grade for valves, pipes and heat exchanger tubes. Considering the increased corrosion resistance 316 grade is largely used in chemical processing and storage equipment. To confirm the composition of the hopper tube, EDX was carried out on hopper tube sample. As shown in Table 1, composition of hopper pipe sample agrees well with 316 grade stainless steel. Further, Figure 1 shows the microstructure of the as received failed sample, highlighting typical austenite grains, confirming austenitic stainless steel grade.

**Figure 1.** Microstructure of hopper pipe showing austenite grains

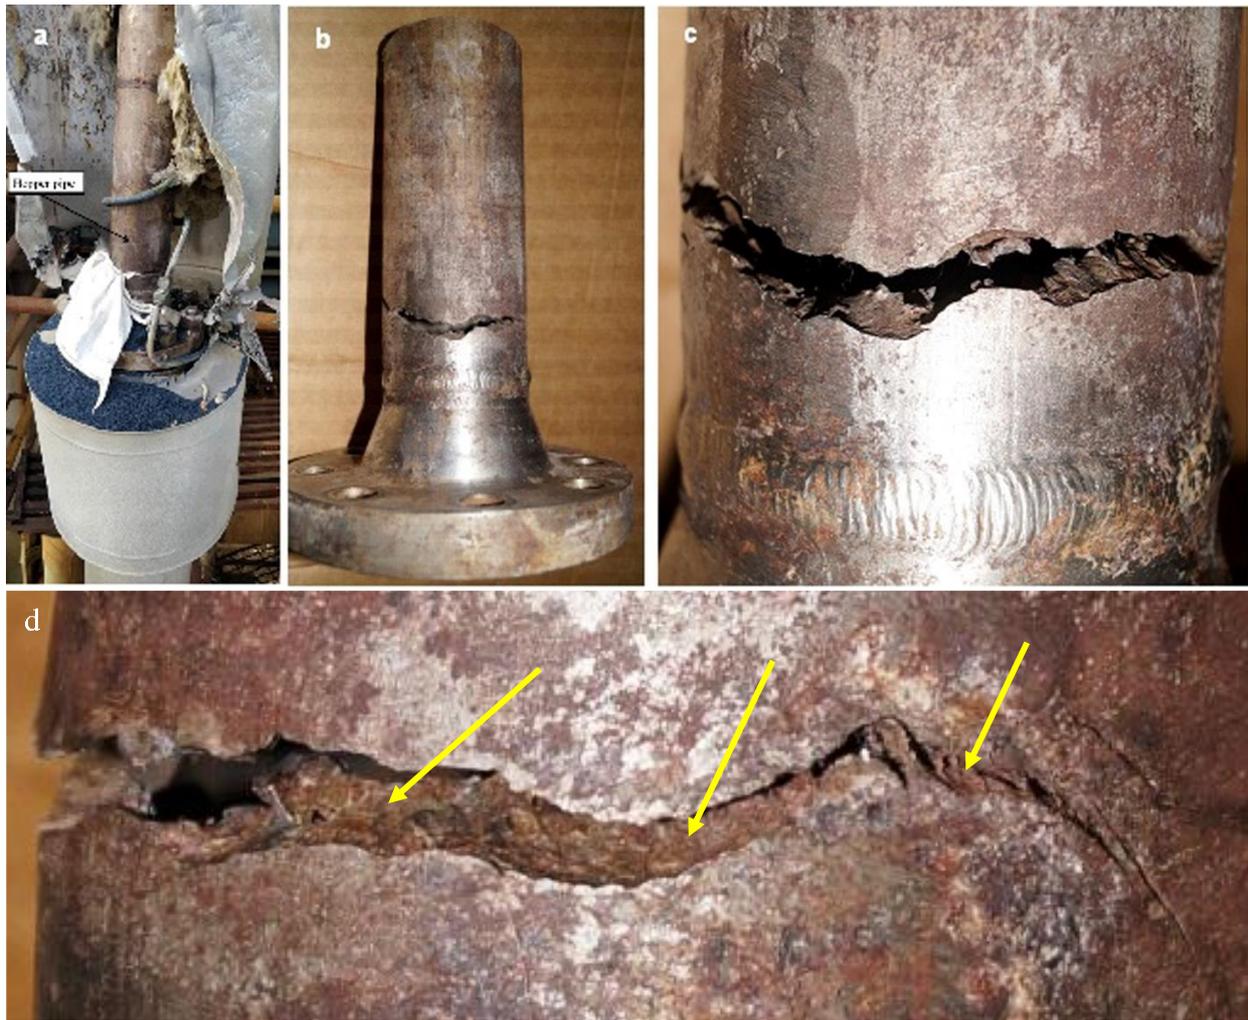
Figure 2a shows the dismantled failed hopper pipe at the discharge unit, that failed during the service. Further, the pipe was removed from the discharge unit and visual examination was carried out on the failed hopper pipe in order to have the better understanding of the failure. Figure 2b and 2c show the close-up images of the fractured pipe and its location. Visual inspection confirms that the pipe suffered a transverse fracture leading to failure of hopper discharge unit. It is to be noted that the fracture region is close to the welded region. Also, corrosion products were observed in the fractured region (Figure 2d), indicating the presence of aggressive environment around the hopper pipe.

**Figure 2.** Visual inspection images showing, (a) failed industrial discharge hopper pipe (b) fractured pipe (c) close up view at fracture location (d) corrosion products observed in the fracture location

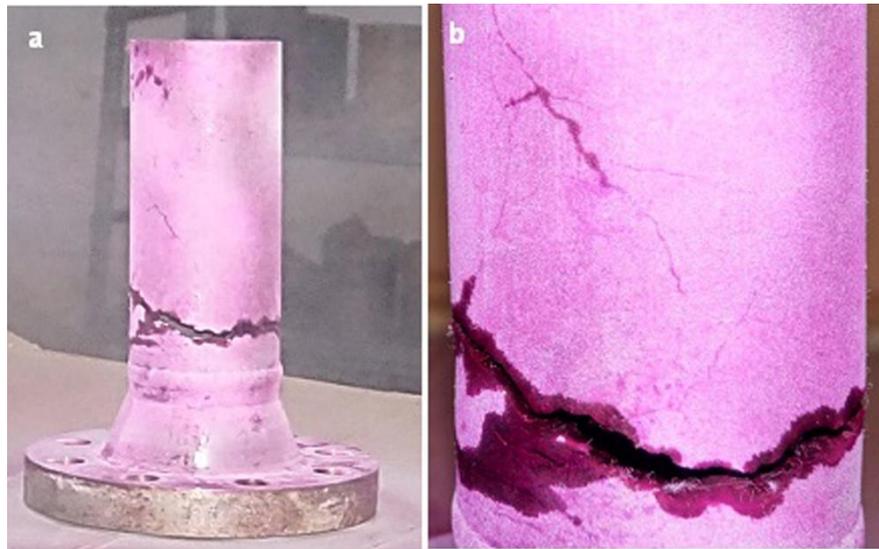
Dye Pentrant Inspection (DPI) test was carried out on the fractured hopper pipe to understand the crack initiation and crack propogation. As shown in Figure 3, many minor cracks were observed on the outer surface of the pipe along with main prominent transverse fracture that caused the failure of hopper pipe. It is to be noted that these minor cracks are not oriented in a particular direction and instead they are orienting in random directions.

**Figure 3.** Dye Penetrant Inspection Test images showing, (a) crack propagation (b) close up view of fracture location

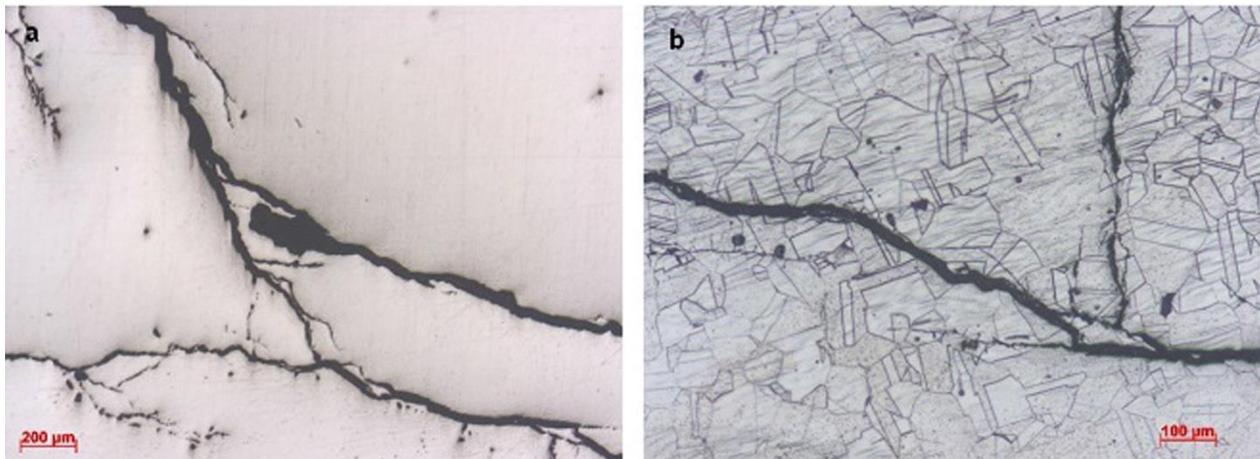
A section having a crack on the surface was sectioned from the hopper pipe and was subjected to detailed metallographic study. Standard metallurgical procedure involving belt grinding, polishing with emery papers, was followed to prepare the specimen for metallurgical analysis. Further, to obtain mirror finish the specimen was polished in a disc polishing unit with 1 micron alumina followed by 0.5 micron diamond polisher. Unetched specimen, observed under the optical microscope revealed crack branches oriented in different directions as shown in Figure 4a. Specimen was then etched to observe how crack pattern is associated with microstructure. Figure 4b shows crack propagation indicating transgranular fracture. Further, the specimen was observed under SEM to confirm the transgranular nature of fracture. SEM images as shown in Figure 5, clearly showed crack propagation cutting through the austenite grains, confirming the transgranular nature of fracture. Energy dispersion spectrometer in combination with SEM was used to analyze the chemical composition of the corroded zone observed in the transgranular fracture. As shown in Figure 6, Chlorine content was clearly observed, along with other major elements of SS 316, indicating chloride formation which might have led to stress corrosion cracking.

**Figure 4.** Optical images showing transgranular fracture: (a) in unetched condition (b) etched condition

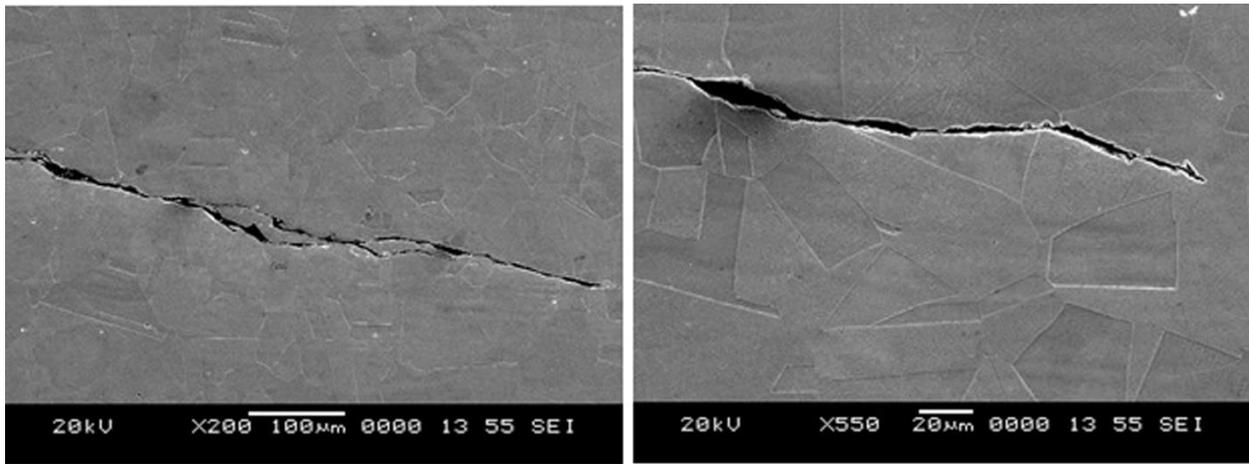
**Figure 5.** SEM images showing transgranular fracture

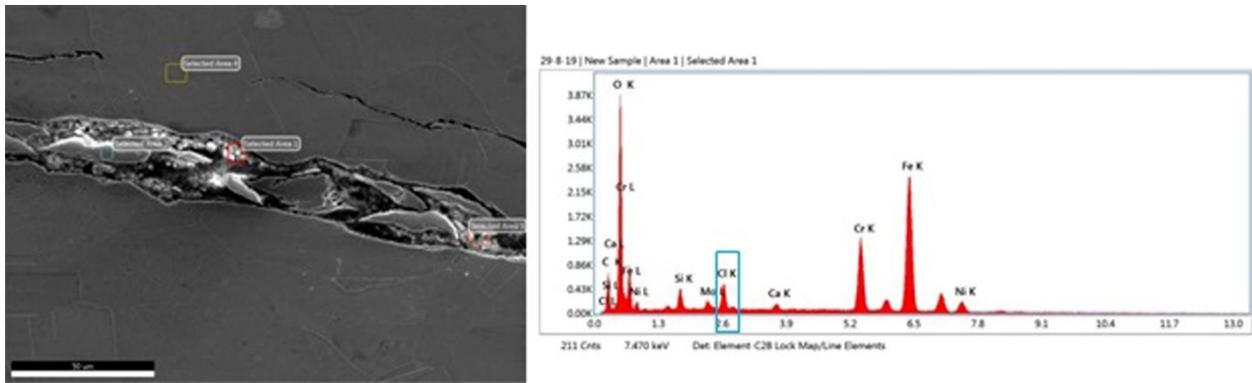
**Figure 6.** EDX showing chlorine content in the fractured region

The detailed investigation carried out on fractured hopper pipe of an oil and natural gas industry concludes that, stress corrosion cracking is the root cause of failure. Chloride formation at the outer surface degraded the material and acted as the crack initiation point. Further, the fatigue stresses because of service conditions present in the pipe accentuated the propagation of crack in a transgranular fashion leading to stress corrosion cracking. Cathodic protection or suitable polymer coating should be considered as the preventive measures to avoid stress corrosion cracking in future.

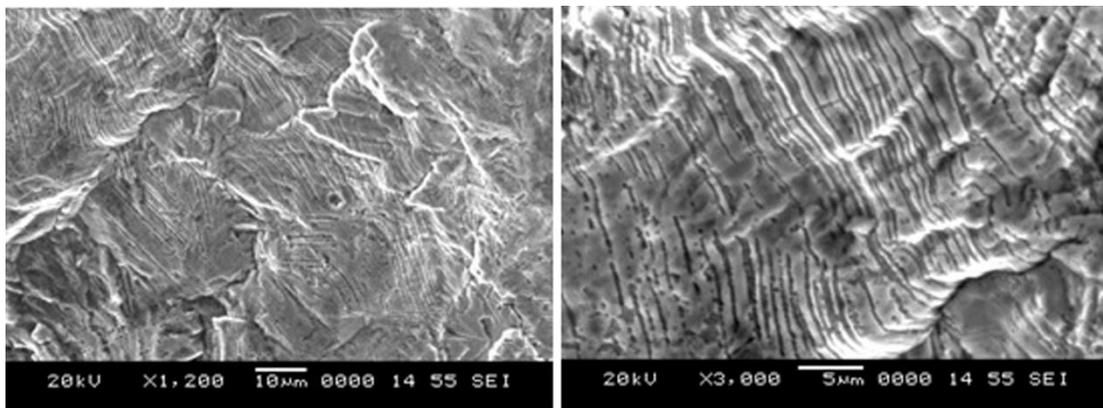
One of the minor cracks was opened and was observed under the SEM to study the mode of fracture. Portion of the pipe having a small crack was sectioned using power hacksaw, leaving around 2 cm each from both the sides of the crack. Care was taken to protect the fracture surface as it was covered with a Teflon tape to avoid any surface debris or water, flowing through it. Once the specimen containing fracture was obtained, it was held in the grippers of tensile testing machine with crack at the center. Using this setup, uniform load was applied and the specimen was separated into two parts without damaging the fracture surface. In general, transgranular nature of the fracture is associated with either cleavage or striations [7]. In this case, SEM images observed at the fractured region showed striations within the grains, indicating fatigue loading condition as shown in Figure 7.

**Figure 7.** Fractograph images showing striations within the grains
