# Observation of Remedial Works on Failed RC Wall with Innovative EC Geoblock Gravity Retaining Wall

**ABSTRACT** - The paper presents an overview of the construction of a novel EC Geoblock gravity retaining wall intended as a restorative measure to repair a collapsed reinforced concrete (RC) wall. The construction process, including site preparation, pad levelling, block installation, backfilling, and final finishing, is thoroughly covered in the article. This article aims to demonstrate the effectiveness, efficiency and swift implementation of remedial works on collapsed RC wall. The gravity wall's distinctive design elements, which improve its cost efficiency, structural integrity and drainage ability are highlighted. The study also examines the benefits of this novel approach over conventional RC walls, including its shorter construction time and environmental friendliness. By offering a novel construction idea, this ground-breaking block design promotes sustainable development and helps achieve SDG 9: and SDG 11. Moreover, the post project checks on the deflection are less than 10mm which further showed the structural soundness of the novel EC Geoblock gravity retaining wall.

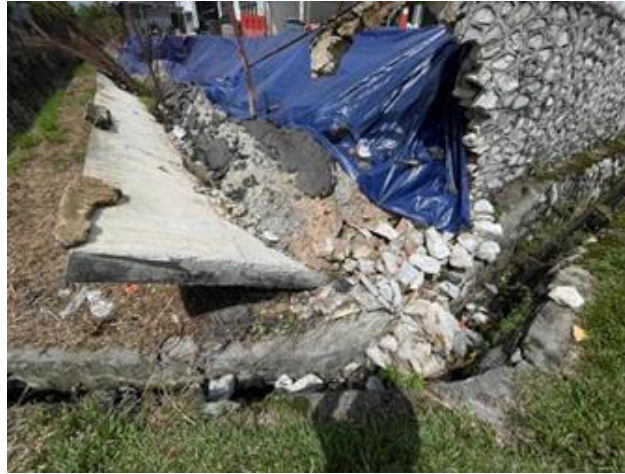
Figure 6. RC retaining wall failure

The remedial process begins with clearing the site where the failed wall possibly due to heavy rainfall is removed from the working area. The RC retaining wall was built in 1994 and failed on 10<sup>th</sup> November 2021. The RC retaining wall was believe to be experiencing overturning and bearing failure (Figure 6) as the generation of pore water pressure from rainfall and car wash activities can exert lateral pressure towards the wall. Simultaneously, the increase in pore water pressure causes reduction in the effective stress as both components make up the total stress. Decrease in effective stress lead to lower shear strength which diminish the bearing capacity of the soil and lower the factor of safety [19] resulting in bearing failure.

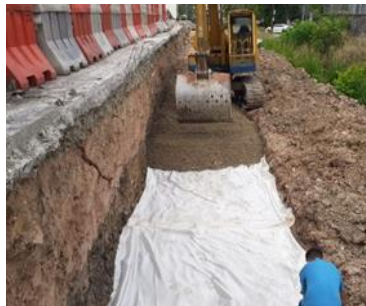
Figure 7. Filling of granular fill

Before construction commence, site investigation consists of 8 mackintosh probes and test pit were carried out to determine the sub-soil condition of the study area. Moreover, relevant design survey plan and building layout were also obtained. The initial stage of the process involves the clearance of debris from the collapsed area. Subsequently, the ground is levelled, and granular material is filled (Figure 7) and compacted to form a flat base (Figure 8).

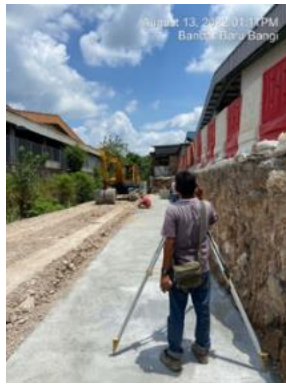
Figure 11. Alignment checking

The alignment is checked with theodolite to ensure the pad is flat before laying of EC Geoblock (Figure 11). EC Geoblocks are placed according to the approved drawing with manual labour efficiently (Figure 12). The alignment of each layer of EC Geoblock are checked with spirit level to ensure the structure is stable.

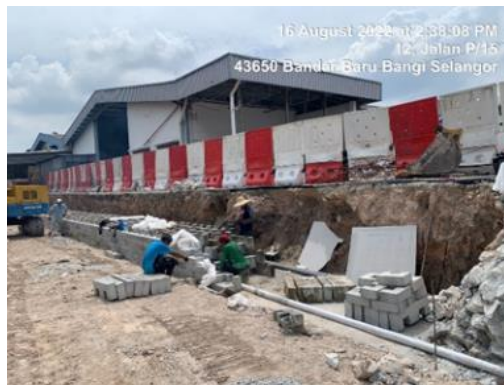
Figure 13. Subsoil pipe installation and laying of EC Geoblock

Subsoil pipe is installed at the bottom of the wall. This step ensures the surface runoff and water can be effectively diverted from the granular filled in between the blocks. After placing of subsoil pipe, the process of laying EC Geoblock continue (Figure 13) without interruption, reducing the risk of building up pore water pressure that can cause potential damage to the wall.

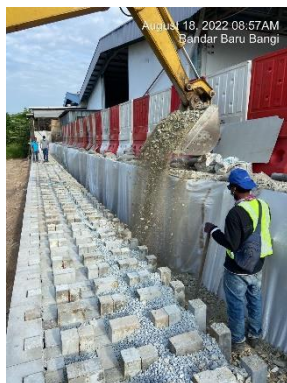
Figure 14. Backfill crusher run

The selection of suitable backfill material is vital for the longevity and stability for many structures especially retaining wall as it directly affects the effectiveness of wall to resist lateral deflection and settlement. Granular material is often a great and popular choice for backfill material due to its great draining ability and the ease of compaction to mitigate future risk of erosion. Hence, crusher run which is a type of granular material is chosen as the backfill material for the remedial work. Backfill (Figure 14) and compacting of crusher run (Figure 15) are done when each layer of EC Geoblock is laid to ensure the fill were well compacted. Subsequently the rubble wall is constructed at the end of the wall which connect seamlessly with the EC Geoblock gravity wall (Figure 16).

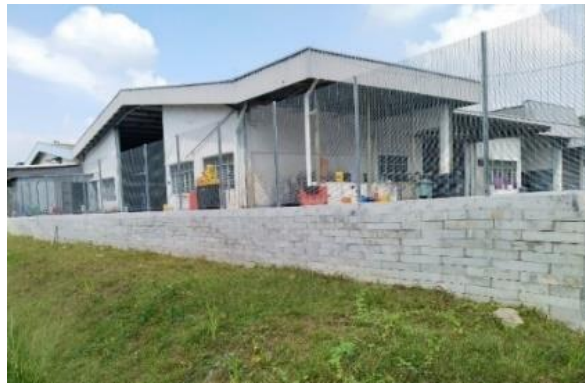
Figure 17. EC Geoblock gravity retaining wall

Broken slabs were cut and used as backfill material to reduce wastage. The construction of EC Geoblock gravity retaining wall were completed from 6<sup>th</sup> August 2022 to 23<sup>rd</sup> August 2022. In other words, the entire process of remedial work ends within a month which proved its worth in emergency remedial work. The end result is aesthetically pleasing and the facing of the wall have abundant design potential (Figure 17).

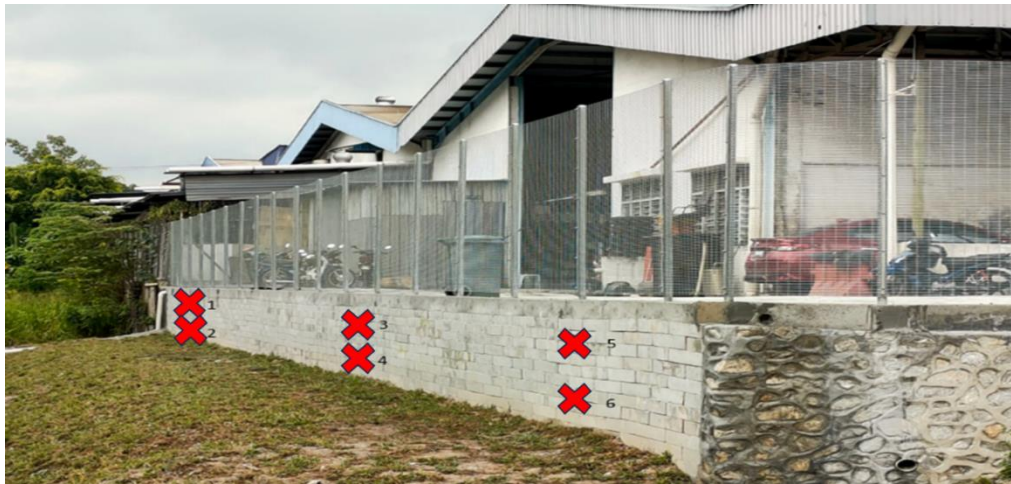
Figure 18. Reference points

Several reference points are selected to monitor the horizontal displacement of the wall. Horizontal displacements were measured at six points distributed across the wall to assess potential horizontal wall movement as shown in Figure 18 were taken after backfilling. The allowable displacement according to BS 8002 is 0.5% of the wall's height which in this case is around 10mm which is above the maximum displacement recorded in site. Hence, it can be proved that the EC Geoblock wall is safe and feasible. Table 1 has summarized the displacement of the six reference points.

Reference Point	Displacement (mm)
Point 1	3
Point 2	4
Point 3	2
Point 4	3
Point 5	6
Point 6	5
