# Repairing Materials for Different Post Fire - Damaged Structural Concrete Members: A Critical Review

**ABSTRACT** – When concrete structures are exposed to elevated temperatures or fire, their strength begins to degrade. The major problem is that the structure induces cracks, which let the aggressive material enter the concrete and the steel reinforcement corrosion. Therefore, the damaged member should have been strengthened or repaired; sometimes, the repair is chosen over demolition because it is more economical. Researchers used materials to repair heat-damaged concrete, such as fiber-reinforced polymer (FRP) composites, shotcrete, ferrocement, epoxy resin mortar, and fiber-reinforced concrete. The compatibility of these materials should be investigated, for example, the bond strength between repair material and substrate. Ferrocement can restore stiffness and toughness, while a structure with FRP jacketing cannot regain stiffness. Reviewing post-fire strength and repairing materials has not been done; therefore, this study highlights the strength loss of fire-damaged concrete and the repaired structure's confinement.

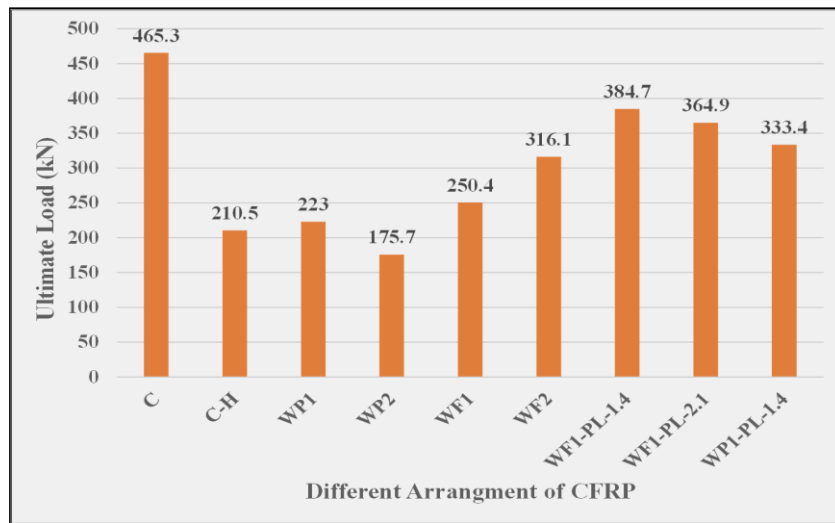
Figure 3. Ultimate Load of Control Samples and CFRP Repaired Samples.

increased by 20 %, as shown in Figures 2 and 3. For samples repaired with CFRP plate and sheet, the increase in ultimate strength and toughness compared to control samples is summarized in Table 1.

Table 1 shows the percent of the estimated load of the repaired specimen compared to the original specimen. The repaired samples' maximum deflection, ultimate load, and toughness are compared in Figure 2 to Figure 4. As presented, fully wrapping the column using a plate has a good restoring of the load carrying capacity other than other types, which is 83% of the control samples load carrying capacity. The sample that was fully wrapped with two layers had a higher toughness when compared with the other samples.

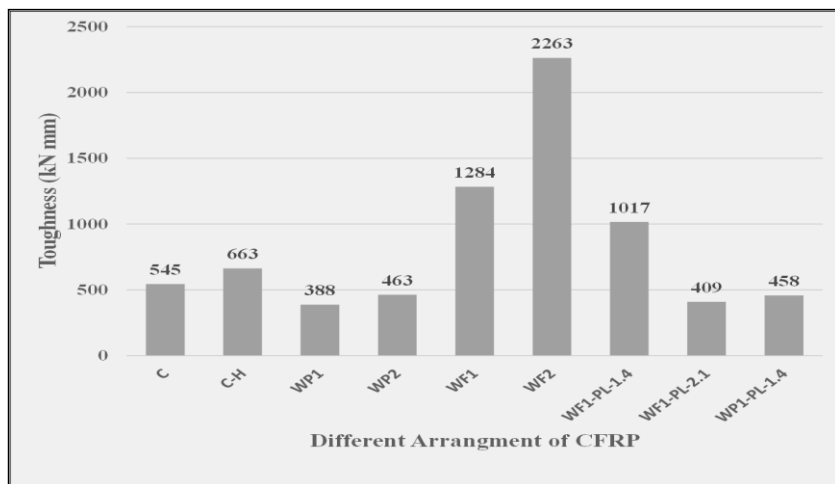
Figure 4. The toughness of the columns after exposure to high temperature and after repairing with CFRP.

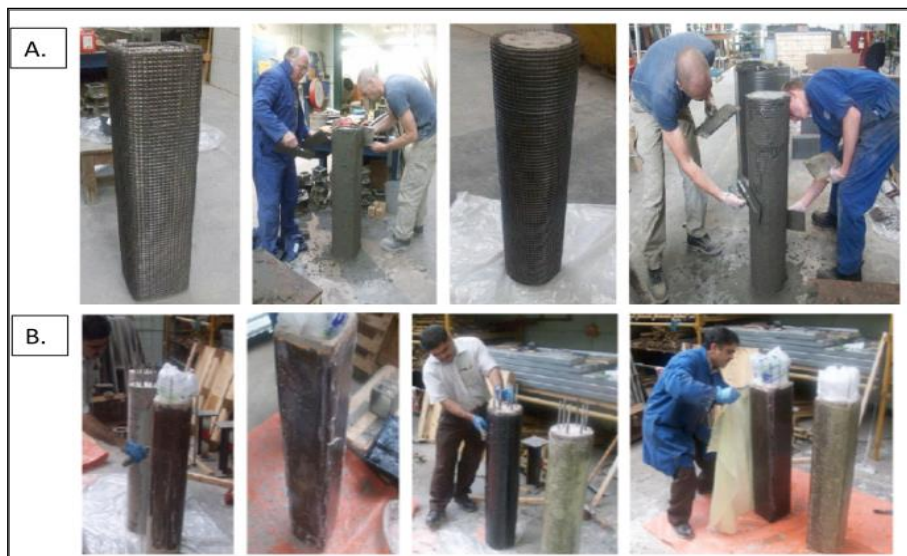
**Figure 6.** Repairing procedure application of (A) Ferro cement, (B) FRP jacketing [10].

Compared to the ferrocement jacket post-heated columns under similar axial load effects, the FRP jackets exhibit a significantly developed energy dispersion capacity. This is due to the after-heating columns' achievement restored with FRP jackets with enhanced strength and toughness. The relative strengthening effect of using FRP or ferrocement jackets on circular columns was greater than on square columns. This may be because the FRP or ferrocement jackets for circular shapes were subjected to hoop tension, and the concrete cores of circular columns were subjected to uniform radial compression, thus creating uniform passive pressure of confinement. In contrast, the lower reinforcement effect for square parts is possibly due to the transmission of high confining pressure/stress concentration at the corners, resulting in a lower failure load for the FRP or Ferro-cement jackets relative to the sides. Lenwari et al. [11] experimented with using FRP sheets for after-fire restoration of concrete strength under different situations such as:

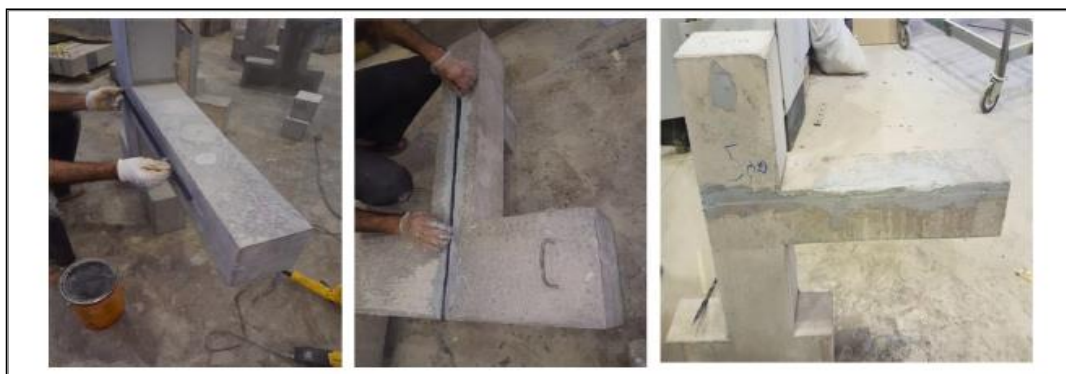
**Figure 10.** Creating grooves on the top of the beam and adding strips [1].

Near-surface mounted CFRP was used in another research by Ashteyat et al. [1] for cantilever beam repair produced by self-compacting concrete (SCC), and the strip of CFRP was applied to the top of the beam because the top fiber of the beam is the portion where bending stress occurring (Figure 10). Eight reinforced cantilever beams were placed in pairs in an electric furnace.

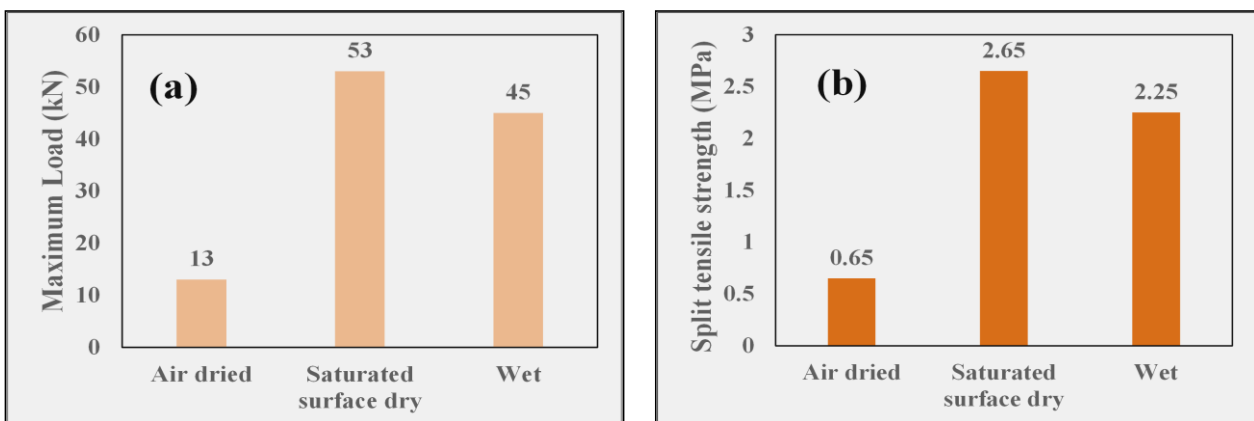
**Figure 13.** Comparison between (a) Maximum load and (b) Splitting tensile strength in different moisture conditions.

The bond strength by the mean of splitting tensile strength of UHPFRC with normal strength concrete was compared in different moisture conditions, as shown in Figure 13.

The maximum load carried by the sample in splitting in the air-dry condition is smaller than in other conditions, 13 kN, 25%, and 28% of saturated surface dry and wet conditions, respectively. From that, it can be concluded that when applying UHPFRC to normal strength concrete, the surface in saturated surface dry is better. Also, in wet conditions, the load-carrying capacity is high enough. The bond strength between UHPFRC and normal strength concrete increases with the substrate moisture content; however, the bond strength decreases if the substrate surface is wet.

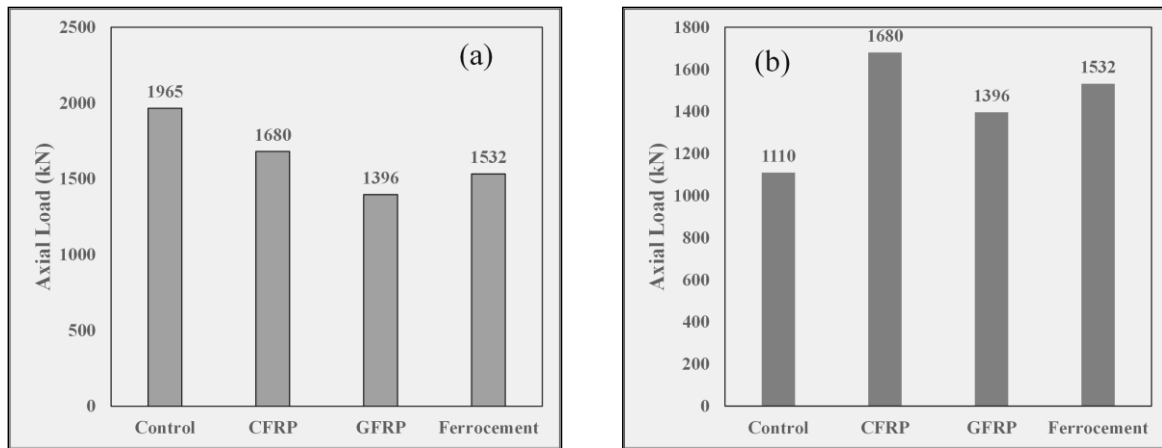
**Figure 14.** Comparison between repaired and control samples, (a) Non-heated and Non-repaired, (b) Heated and Non-repaired.

From Figure 14, the comparison between three different materials, namely CFRP, GFRP, and ferrocement, is conducted. It can be seen that the axial load-carrying capacity for CFRP is 1680 kN which is 85% of the non-heated and non-repaired sample and 151% of the heated sample. For GFRP, the axial load is 1396 kN which is 71% of non-heated and non-repaired samples and 126% of heated and non-repaired samples, respectively. By using ferrocement for repairing, the axial load is 1532 kN, which is greater than GFRP and smaller than CFRP, and it is 78% of the axial load-carrying capacity of non-heated and non-repaired samples and 138% of the heated and non-repaired samples. The effective material for restoring the load-carrying capacity is CFRP, which had a better result.

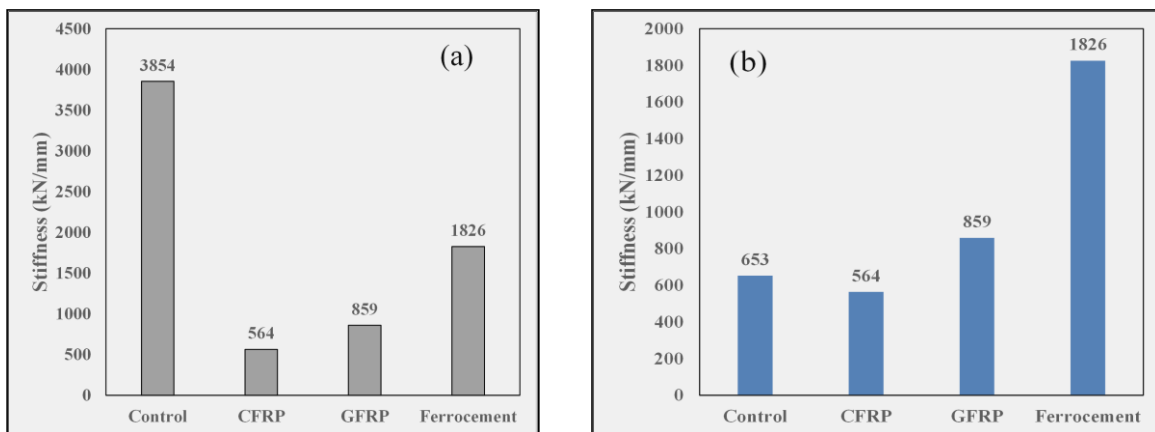
**Figure 15.** Comparison between repaired and control samples, (a) Non-heated and Non-repaired, (b) Heated and Non-repaired.

Evaluation of the restored stiffness of the repaired sample shown in Figure 15 can be seen the figure the stiffness of the non-heated and non-repaired samples is 3854 kN/mm, and the stiffness of the repaired samples with CFRP, GFRP, and ferrocement is 564, 859, 1826 kN/mm, respectively. It can be seen here that the effectiveness of using ferrocement is higher than the two other materials.

Ferrocement can restore stiffness and load carrying capacity 78 and 47% of the control sample's load-carrying capacity and stiffness, respectively; on the other hand, CFRP can restore carrying load capacity to 85% while restoring stiffness up to 15% of the control sample's stiffness. GFRP, compared to CFRP, is better in restoring stiffness, while CFRP and ferrocement, the load-carrying capacity, is smaller.
