# Rock Mass Classification and Geo-resistivity Properties of Granite from Pahang, Malaysia

**ABSTRACT** - In tropical climate, exposed rocks are significantly weathered to form extensive weathering profile, which greatly affect the engineering integrity of the material. Geophysical method such as the electrical resistivity mapping have increasingly being used in the classification of the geoenvironmental properties of rock slope alongside conventional field and laboratory testing. In this study, comprehensive assessment of the weathered granite is carried out on selected exposed granite slopes in the Karak-Lanchang area, Pahang. Petrological analysis indicated quartz minerals as being the most stable mineral among the weathering grade. With increasing weathering grade, for physical properties of the granite of porosity and moisture content shows positive trend, whereas the specific gravity, slake durability index, and ultrasonic pulse velocity shows negative trend; for mechanical properties, the surface hardness rebound value, point load strength, and uniaxial compressive strength shows negative trend with increase of weathering grade. Mapping from the resistivity zones correlate

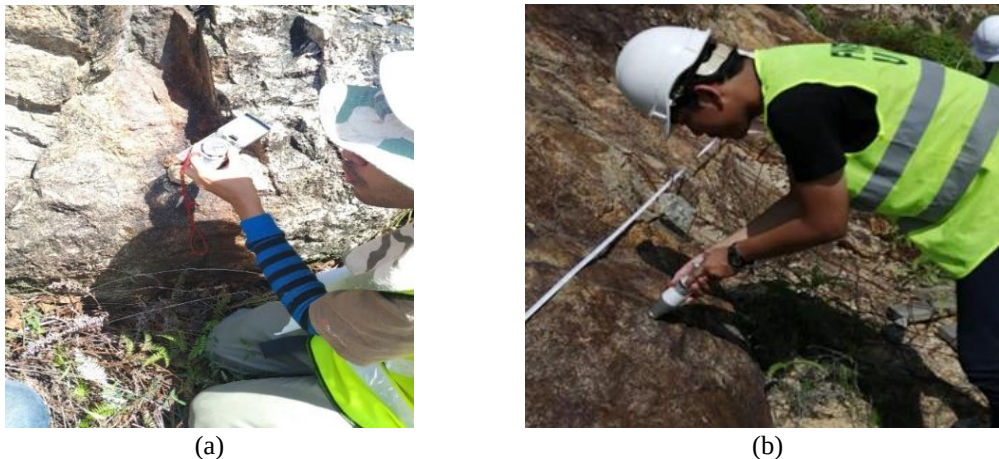
Figure 2. Field mapping of slopes. (a) Scanline mapping (b) Measurement of surface hardness of rock surface using Schmidt Rebound Hammer

Rock slopes discontinuity mapping were carried out by implementing the scanline method by laying out measuring tape along the rock slopes, and keeping the tape as close as possible to the surface of the slope, as shown in Figure 2 (a). The dip and strike of joint and fractures, as well as other relevant parameters for analysis, were measured along the scanline. The discontinuity mapping method was conducted in accordance to the British Standards Institution (BSI) [30]. In addition, the weathering condition of the slopes were mapped. Investigation for the weathering condition of the rock slopes were carried out following the standard of BSI [31]. For each identified weathering grades, in-situ surface hardness tests were carried out using the Schmidt rebound hammer. Repeated reading of surface hardness were taken along the length of scanline, in order to quantify the weathering grade of the rock mass along the slopes, as shown in Figure 2 (b). A set of readings are taken for each section, with the application of the hammer to different part of the rock surface for each impact. Following the standards of International Society of Rock Mechanics (ISRM) [32], measurement in group of 10s, with the 5 lowest reading discounted and averaging the highest 5 readings for discontinuity reading, were used to calculate the average reading for each measured section of the slopes.

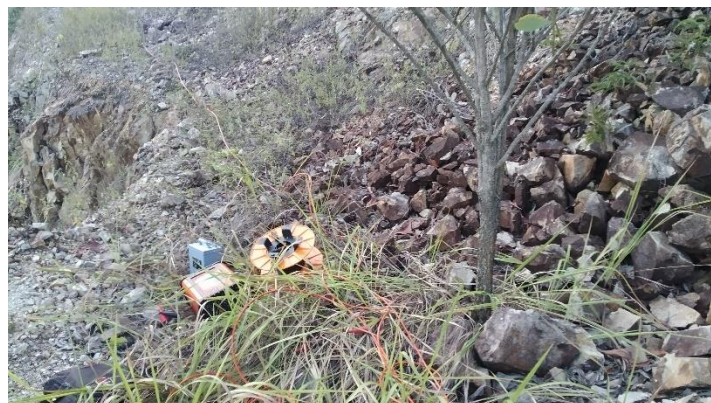
Figure 3. Setting up of electrical resistivity mapping apparatus on the site

Electrical resistivity mapping was carried out to identify the subsurface condition of the rock slopes. The electrical resistivity lines were set up using the ABEM Terrameter LS 2, connected to two multicore cables with stainless steel electrodes that are hammered into the ground in a generally straight line with constant spacing, connected to the 'take out' of the cables (Figure 3). The electrical resistivity mapping was carried out following the standards by ISRM [32] for land geophysics in rock engineering. The main unit ABEM Terrameter LS2 and 12 V battery, located at the centre of each surveying line. The resistivity lines was set out along roughly E-W alignment along rock slopes.

Testing configuration was based on the Schlumberger array, with the use of two (2) resistivity land cables and forty-one (41) electrodes. The Schlumberger array was used for the survey due to it providing dense near-surface coverage for resistivity data, with good vertical resolution and clear image of groundwater and sand-clay boundaries as horizontal structures [33].
