RESEARCH ARTICLE

The effect of adding *Casuarina equisetifolia* fruit powder on the wear, impact strength, and hardness of motorcycle disc brake pad composites

Nurin Tammima, Heri Yudiono*, Muhammad Irfan Rifaldi

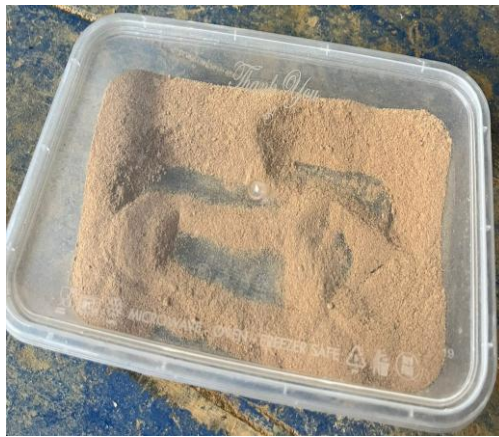
Figure 1. *Casuarina equisetifolia* fruit powder

Casuarina equisetifolia fruit waste was collected from Lombang Beach, Sumenep Regency, East Java, Indonesia. The fruit was then dried under the hot sun until it turned reddish brown and did not release liquid when broken (± 7 days). After drying, the fruit was ground in a chopper. Then, the powder was sieved using a 100-mesh sieve. The visual appearance of the prepared *Casuarina equisetifolia* fruit powder is shown in Figure 1. A density test was conducted to determine its specific gravity. To better understand the material's properties and suitability as a composite filler, the proximate, ultimate, and biochemical analysis of the *Casuarina equisetifolia* fruit waste is presented in Table 1 [8].

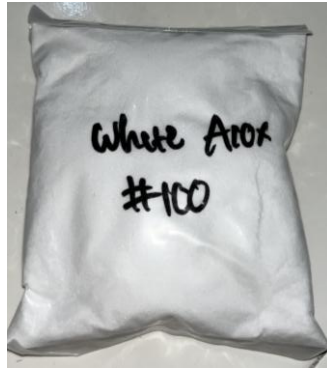
Figure 2. Aluminium oxide powder

Alumina, or aluminum oxide (Al_2O_3), is a white, amorphous powder that is amphoteric and extremely stable. In nature, alumina can also be found as the mineral corundum. represents an extremely hard substance that is used as a polishing and grinding abrasive [9]. Aluminum oxide powder was obtained from a chemical supply store in Semarang. The powder size is 100 mesh. The detailed physical and mechanical properties of the aluminum oxide are presented in Table 2 [9]. The visual appearance of the aluminium oxide powder used in this study is shown in Figure 2.

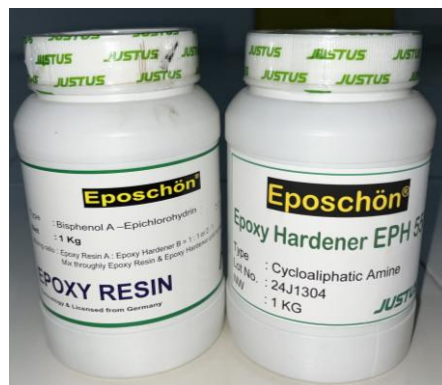
Figure 3. Epoxy resin

Bisphenol A-Epichlorohydrin type epoxy resin, and Cycloaliphatic Amine type hardener are used as the matrix. Epoxy resin has several advantages, including high-temperature resistance and excellent adhesion. Binders play a crucial role in friction materials, keeping everything together and withstanding high temperatures and pressures [10]. The specific physical and mechanical properties of the epoxy resin used as the matrix are detailed in Table 3 [11]. The packaging and visual appearance of the epoxy resin and hardener are shown in Figure 3.

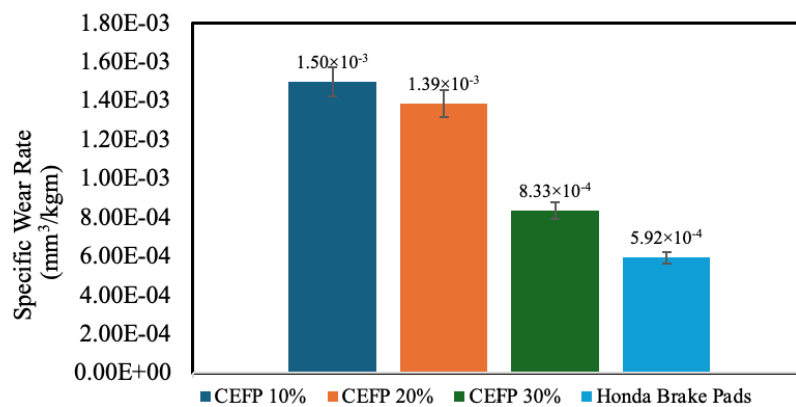
Figure 5. Average specific wear rate

Wear tests are performed to determine the specimen's wear value. The tool used is the Ogoshi High Speed Universal Wear Testing Machine (OAT-U Type). The results of this test are the wear width values for the test specimen, which are then averaged. The testing was carried out three times for each composition variation in both the experimental and control groups to increase data accuracy. The test results are shown in Table 5. Figure 5 shows that the average specific wear rate varies across the different variations. The 10% CEFP variation has an average specific wear rate of $1.50 \times 10^{-3} \text{ mm}^3/\text{kgm}$. The 20% CEFP variation has an average specific wear rate of $1.39 \times 10^{-3} \text{ mm}^3/\text{kgm}$. The 30% CEFP variation has an average specific wear rate of $8.33 \times 10^{-4} \text{ mm}^3/\text{kgm}$. Meanwhile, the control group has an average specific wear rate of $5.92 \times 10^{-4} \text{ mm}^3/\text{kgm}$. The graph shows that the average specific wear rate of the experimental group decreased with increasing volume fraction of *Casuarina equisetifolia* fruit powder. The difference in the average specific wear rate between the experimental and control groups was 23.70%. Changes in the average specific wear rate showed a consistent downward trend. The average specific wear rate closest to the control group was the 30% CEFP specimen, which decreased by 28.93%. The decrease in the specific wear value in the experimental group may occur due to an increase in the volume fraction of *Casuarina equisetifolia* fruit powder. This is consistent with the findings of Sukrawan et al. [16], who reported that the higher the weight fraction of bamboo fibre, the lower the wear rate, resulting in a longer service life, better heat resistance, and increased hardness of the composite material. Similarly, the research by Kholil et al. [17] shows a decrease in wear with increasing lignin content in coconut fibre. In addition, the size of the powder used can affect the wear resistance of the composite material. As in the research of Nandiyanto et al. [18], which states that reducing the particle size of rice husks can reduce the wear rate and increase the friction coefficient of the composite material.

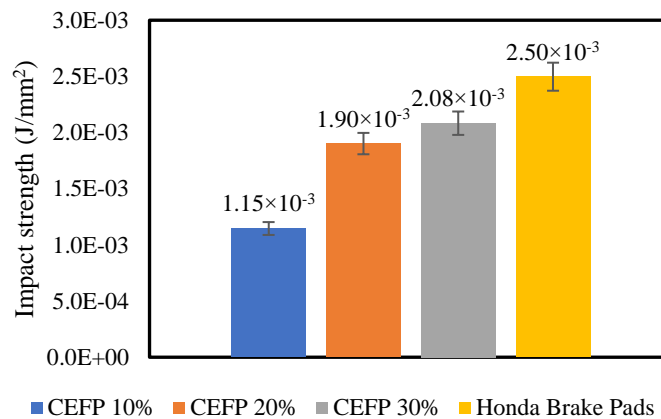
Figure 7. Average impact strength

Figure 7 shows that the average impact strength varies across the different variations. The 10% CEFP variation has an average impact strength of 1.15×10^{-3} J/mm². The 20% CEFP variation has an average impact strength of 1.90×10^{-3} J/mm². The 30% CEFP variation has an average impact strength of 2.08×10^{-3} J/mm². Meanwhile, the control group has an average impact strength of 2.50×10^{-3} J/mm². The graph shows that the average impact strength of the experimental group increased with increasing volume fraction of *Casuarina equisetifolia* fruit powder. The difference in the average impact strength of the experimental group was 37.35%. Changes in the average impact strength showed a consistent upward trend. The impact strength closest to the control group was the 30% CEFP specimen, which decreased by 20.19%. An increase in the impact strength in the experimental group may occur due to an increase in the number of volume fractions of the *Casuarina equisetifolia* fruit powder. It is in line with Fuad and Yudiono's [21] that more aegle marmelos shell particles can increase the impact strength, hardness, and wear resistance of composite materials. In the study, Wang et al. [22] observed the same trend: the greater the amount of corn straw fiber mixture added, the greater the composite material's impact strength. In addition, Liu et al. [23] state that the rough surface of natural fibers can provide good mechanical interlock between the fibres and the composite matrix, thereby improving energy absorption.

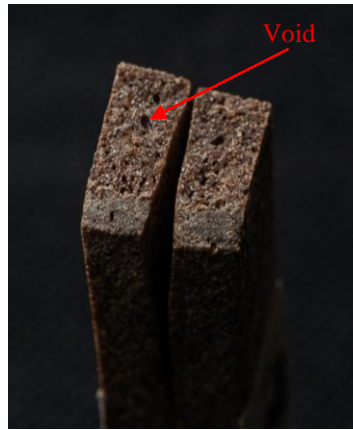
Figure 8. Fracture shape

Figure 8 shows that the impact test conducted resulted in deformation in the form of a fault. During the impact testing, the test object breaks into two parts. After visual observation, the fault results indicate that the fracture in the test specimen is granular. It is characterized by pieces that can be reattached. The fractured surface is shiny when exposed to light. As well as on the observation of the fault surface, there are crystalline granules. The increase in impact strength with higher CEFP content shows that the composite can absorb more energy before breaking. This may happen because the particles help spread the stress more evenly inside the material. The fracture surface shows brittle behaviour, but the higher impact value at 30% CEFP suggests that the particles help slow down crack growth. Even so, the current explanation is still general. The real fracture mechanism, whether caused by particle breakage, matrix cracking, or weak bonding, cannot be

clearly seen from visual observation alone. A more detailed fracture surface analysis is needed to understand better how the particles improve energy absorption.

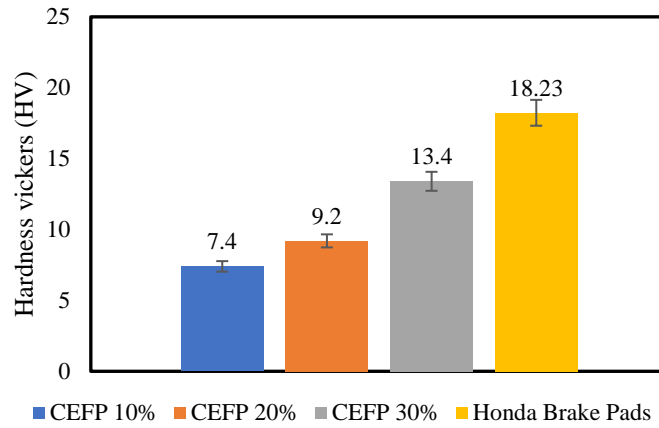
Figure 9. Average hardness Vickers

Figure 9 shows that the average hardness varies across the different variations. The 10% CEFP variation has an average hardness of 7.4 HV. The 20% CEFP variation has an average hardness of 9.2 HV. The 30% CEFP variation has an average hardness of 13.4 HV. Meanwhile, the control group has an average hardness of 18.23 HV. The graph shows that the average hardness of the experimental group increased with increasing volume fraction of *Casuarina equisetifolia* fruit powder. The difference in the average hardness of the experimental group was 34.99%. Changes in the average hardness showed a consistent upward trend. The average hardness closest to the control group was the 30% CEFP specimen, which decreased by 36.04%. The increase in hardness in the experimental group may be due to a higher volume fraction of *Casuarina equisetifolia* fruit powder. This is in accordance with the research of Pujari and Srikan [24], which shows that the hardness of composite materials increases with increasing volume fraction of palm kernel powder. Likewise, in the study by Akaluzia et al. [25], it was found that the greater the amount of hardwood charcoal powder used, the harder the composite materials become. In addition, the use of Al₂O₃ also affects the hardness value of resin matrix composites. Bazrgari et al. [26] reported that the addition of Al₂O₃ powder to resin matrix composites also increases the hardness. The hardness test results showed a correlation between the specific wear and hardness values: the higher the hardness, the lower the wear. This is consistent with the research by Ramanathan et al. [27], which found that higher hardness is associated with lower wear.

The increase in hardness with increasing CEFP content indicates that the filler enhances the composite's resistance to surface indentation. The particles reduce the mobility of the epoxy matrix, thereby strengthening the material under pressure. The addition of Al_2O_3 also contributes because it is a hard ceramic material. However, the hardness of the 30% CEFP specimen (13.4 HV) is still lower than that of the commercial pad (18.23 HV). This difference may be caused by uneven particle distribution, particle clumping, or weak bonding between the filler and the matrix. Therefore, further microstructural analysis is needed to clearly explain how the particles improve hardness and why the hardness value remains below the commercial standard.
