RESEARCH ARTICLE

Crack repair of aluminium components using glass fibre reinforced polymer composite patches: Effect of patch thickness on tensile behaviour

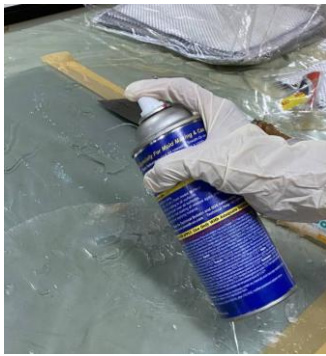
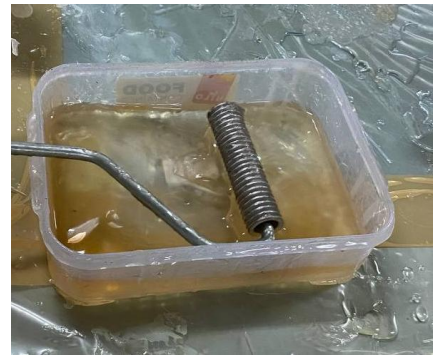
(a) Spraying process of workplace

(b) Cutting process of glass fibre

(c) Stirring process of resin and hardener

Figure 2. Sequential steps in the preparation process

The repair patches were prepared using woven roving E-glass fibres supplied by the UPM Solid Laboratory. The fibres had a modulus of elasticity of 72 GPa and tensile strength of 1700 MPa. EpoxAmite 100 epoxy resin and 103 slow hardeners were used as the matrix. To prevent the resin from hardening too early in the process, a 103 slow hardener is used at a 3:1 mix ratio (resin: hardener). All materials and equipment were prepared prior to fabrication due to the limited working time caused by the exothermic curing reaction of the epoxy system. The working surface was sprayed with Smooth-On Universal Mold Release to prevent adhesion between the repaired specimen and the working surface during curing (Figure 2 (a)). Glass fiber reinforcement was cut to dimensions of 40 mm × 150 mm according to the required patch geometry using standard cutting tools, as shown in Figure 2(b). The epoxy resin and compatible slow hardener were mixed at a 3:1 ratio (resin: hardener) according to the manufacturer's guidelines. The components were combined in a disposable mixing container and stirred for 3-5 minutes using a stir stick, starting slowly to minimize air entrapment and gradually increasing the mixing speed until a homogeneous mixture was obtained (Figure 2(c)). All mixing was performed

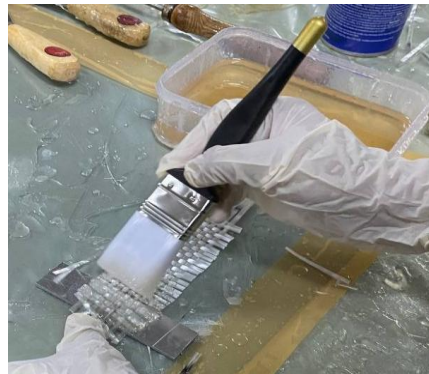
Figure 3. Layering process of composite material on a cracked plate

at room temperature. The prepared epoxy was applied to the cracked aluminium plate using a brush, and the glass fiber patch was placed over the damaged region with sufficient overlap onto the intact surface (Figure 3). A scraper was used to remove trapped air and ensure proper adhesion. For multi-layer repairs, epoxy resin was applied between successive layers until the required number of layers was achieved. The repaired specimens were cured at room temperature for 24 hours to ensure complete polymerization and bonding of the composite repair.

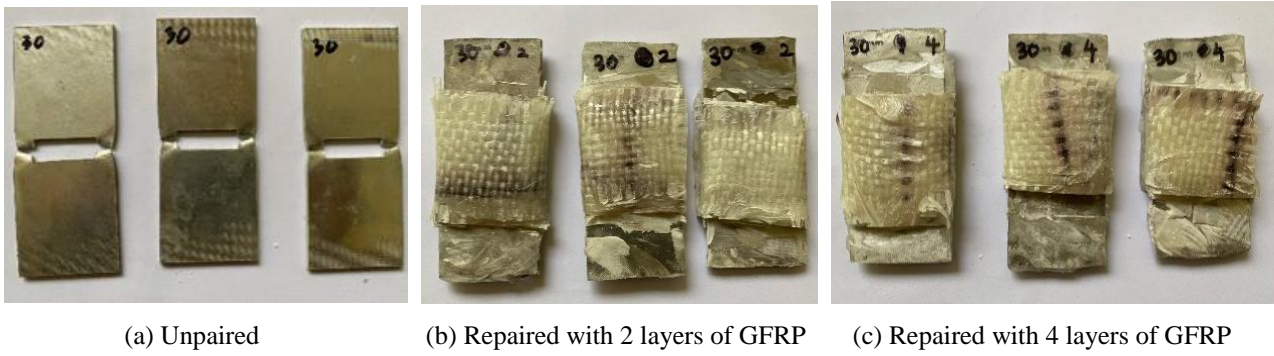
Figure 10. Edge-cracked specimens with a crack length of $a = 15$ mm: (a) unrepaired, (b) repaired with 2 layers of GFRP, and (c) repaired with 4 layers of GFRP

The centre-cracked aluminium specimens exhibited trends similar to those of the edge-cracked ones, but with a more pronounced stress concentration due to the central crack geometry. Figures 8-10 show centre-cracked specimens with varying crack lengths. Unrepaired specimens failed rapidly at relatively low stress levels, exhibiting stress–strain curves with an abrupt fracture immediately after the linear elastic region. In contrast, repaired specimens showed a more gradual failure response due to load redistribution by the composite patch. Repair with GFRP patches significantly enhanced tensile performance. At a crack length of 5 mm, two-layer patches provided noticeable strength recovery, while four-layer patches achieved a maximum stress of 184.67 MPa (Table 2). Remarkably, this value exceeded the maximum stress of the unrepaired specimen with a 5 mm crack length of 165.66 MPa and was approximately 49% higher than the ultimate tensile strength of the original uncracked Aluminium Alloy 6061-O of 124 MPa, indicating that the GFRP patch not only compensated for the crack but also provided additional stiffness and enhanced load-bearing capability.
