Experimental study of the effects of semi-elliptical defects on the API X52 pipeline and its repairation by welding

ABSTRACT – The aim of the study is to investigate experimentally the influence of the semi-elliptical defect on the steel of grade API 5L X52 pipeline and its repairation by welding operation to keep the safety of hydrocarbons transport network. The tests have been performed on the specimens with/without semi-elliptical defects by using two ratios a/c and a/t , where the defects issue on the piping systems wall is treated by using the welding operation, which focuses on the filling the defected surface as same thickness of the base wall of the pipeline after removing the defects. The decrease of ultimate stress is mainly evident depending on the size of crack, where they compared to the base metal results. The experimental results showed that the reliability of the welding operation is proved especially in the ratio $a/c = 1$, which is similar to that found in automatically welded. It is proved that the ratio $a/t = 0.2$ curve exhibits similarity to the base metal curve and their elongation conforms to API standard of steel X52 grade. Clearly, corrosion defects cause

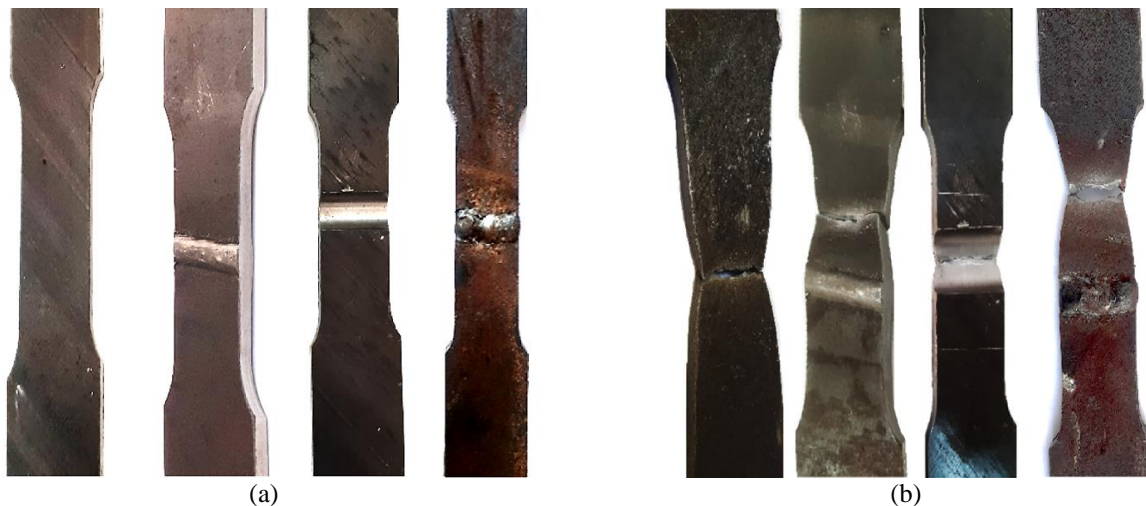
Figure 4. Experimental set up: (a) Before failure and (b) After failure

The main idea of this project about the safety of piping systems were carried out by using the test tensile to study the crack of semi-elliptical as well as the geometry of crack including longitudinal and depth forms, are necessary steps to find an accurately solutions through the study of structural integrity for the hydrocarbons transport as shown in the Figure 4. All performed experiments were tested at ambient temperature by using tensile test along the longitudinal axis of the pipeline.

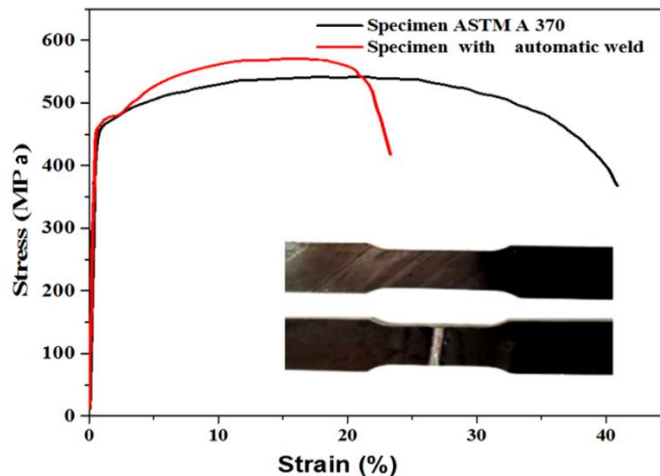
Figure 6. Stress-Strain curve for API X 52 pipeline steel when tested with specimen automatic weld and without weld

Figure 6 has been shown that the obtained stress-deformation curves by using the tensile tests for the base metal and of the weld bead of API 5L X52, could indicate the stress as a function of the deformation in first stage by a linear elastic reach to value of 452 MPa, which corresponds to strain values of 0.5%. In the second stage occurs the plastic deformation through the parabolic form of the stress reach to a maximum value of 558 MPa for the base metal specimen and of 572 MPa for the automatic welding specimen. Finally the third stage is distinguished by increasing plastic deformation to rupture state through the following values 41.86% of the raw metal specimen and of 25.56% for the specimen with automatic weld beads. The tensile test results and the stress-strain curve correspond with the industrial standards [1] and existing literature for pipeline steels, type API X52 [86-88].

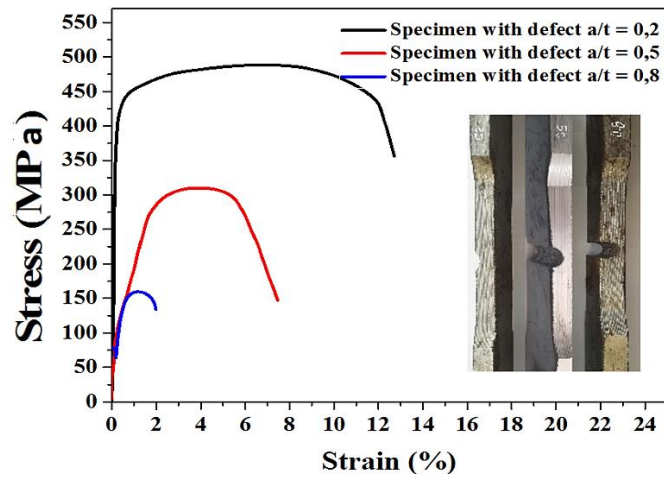
Figure 9. Stress-Strain curve for API X 52 pipeline steel when tested with the various defects tensile specimen of $0 < a/t \leq 0.8$

The second type of semi-elliptical geometry which is represented by the ratio a/t which is based on the variation of depths (a) and fixed length (c) depending on the condition of $0 < a/t \leq 0.8$ [28-30]. Figure 9 shows the curves of the tensile test results of the specimens with presence of defects as displayed in the Table 2 of the a/t ratio.

At the semi-elliptical form $a/t = 0.2$ as the first case where the maximum value of stress reached to 488 MPa and its elongation 12.71%, in the second form is considered by the ratio of $a/t = 0.5$, where the stress is 311 MPa and its elongation 7.36%, in the third form $a/t = 0.8$, where the stress is 160 MPa and its elongation 1.98%. The obtained results explain that the crack phenomenon with semi-elliptical form lead to crack API X52 pipeline which characterized by a reduction of the ultimate stress from the value of 558 MPa for the base metal specimen to 160 MPa for the cracked specimen [17-19]. Depending on these characteristics, which have directly relationship with specimen with defect of the depth (a), where the elongation value decreased from 40.86% to 1.98% led to degradation of piping systems. In addition, the Figure 10 obviously shows that the repairing by the welding process is considered a great challenge where these solutions have a valuable effect on the safety of piping systems through compared to results of the specimens with defects [21-23]. Basing on the increasing of the mechanical characteristics, the first form of ratio $a/t = 0.2$ the maximum value of ultimate stress is become 559 MPa and its elongation value 36.62%. Then in the second form of semi-elliptical for $a/t = 0.5$, where the maximum value of ultimate stress is become 531 MPa and its elongation value 25.36%, with regard to the third form of defect $a/t = 0.8$, the maximum value of ultimate stress 399 MPa and its elongation value 5.18%. This study provided many solutions and more explanations about the crack of semi-elliptical form, where the strategy of solutions is basing on the operation welding through reinforcing the structure at the point of the defect depending the ratios of geometry a/c and a/t . Basing on the criterion to the API [1] standard of steel X52, the increasing of ultimate stresses and elongations have been indicated by depending on the geometry and with different crack depths ratios of semi-elliptical forms, except for the third figure, which is characterized by the lowest depth (a), which is more than half the thickness. The adopted criterion exhibits a potential dependence on defect geometry and possibly on material's strain capacity [88-90]. For this purpose, it cannot that the repairing by welding has a good results when the value of ratio a/t is greater than 0.5. The obtained results proved that the welding process is one of among methods to improve and to increase the degree of safety where these solutions lead to increase the efficiency from 80% to 98% depending on the size of the defects through the ratio $0.5 < a/t \leq 0.8$. It has been shown that the stress-strain curve of $a/t = 0.2$ was identical to the base metal curve including its elongation, where the results agreed with the standard of steel pipe API X52.

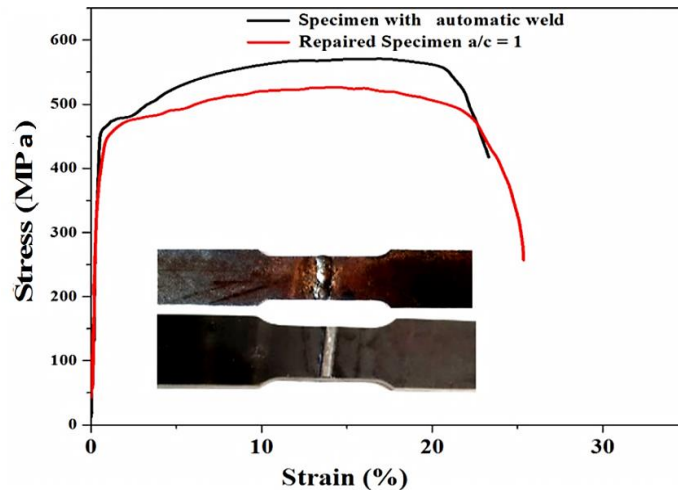
Figure 11. Stress-Strain curve for the compared to different with repaired specimen of $a/c = 1$ and with specimen automatic weld

In order to show the importance of welding operations in the safety of piping systems, the comparison between stress versus strain for two tests specimens related with welding operation through two cases allow to reinforce of the piping systems resistance taking into account the mechanical characteristics of materials. It is necessary to study the efficiency of welding, where the first specimen was carried out automatically and the second specimen was carried out manually for repairing the semi-elliptical defect depending on the ratio $a/c=1$ as shown in Figure 11.

This strategy provided the solutions valuable which led to increase the efficiency through the stress increases for the manually welding, which is agreement with automatically welding, i.e. the difference of 7% for the ultimate stress and of 1% for the elongation. Repairing by welding is one of the important techniques to treat the corrosion phenomenon and to develop the mechanical characteristics in order to reinforce the piping systems, where they obtained results summarized in the Table 3. Automatically welding is one of the important operations, which are carried out on the specimen of pipeline where this technique is featured by the maximum value of ultimate stress 572 MPa and its elongation value 25.56%. Manually welding was carried out on the specimen of semi-elliptical defect to repair and to reinforce, where it is characterized by the maximum value of ultimate stress 531 MPa and its elongation value 25.36%. The experimental results proved that the values of ratio $a/c = 1$ for two cases: the automatic and the manual welding are almost identical in efficiency which can keep the safety of piping systems [90].

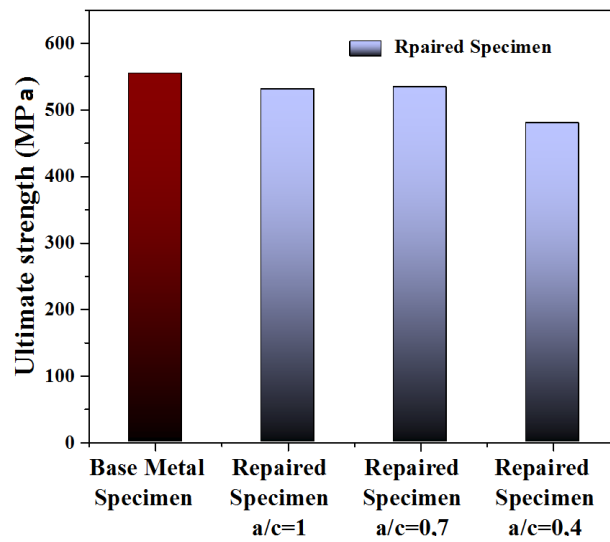
Figure 13. Results of ultimate strength when tested with the repaired welding specimens $0 < a/c \leq 1$

In order to reach an explanation of the semi-elliptical defects through the ratio a/c that the experimental results of the ultimate stresses for three shapes of $0 < a/c \leq 1$ are lower than the experimental result of the base metal specimen as shown in the Figure 12. It can be noted that the obtained results proved the importance of welding operation as shown following. It is worth to mention that three ratios (a/c) for 1, 0.7 and 0.4 of repaired specimens gave values 531 MPa, 533 MPa and 480 MPa respectively which compared with the base metal specimen of 558 MPa, as shown in the Figure 13.

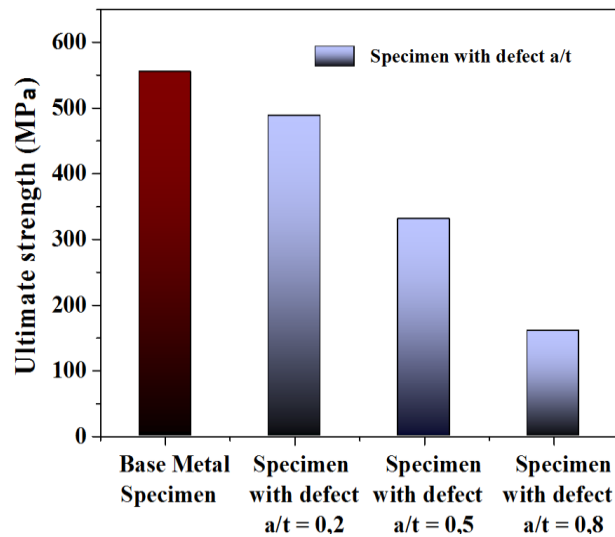
Figure 14. Results of ultimate strength when tested with the defect specimens $0 < a/t \leq 0.8$

It is interesting to remark that Figures 14 and 15 indicated the effect of the defects of ratios (a/t) on the transport systems security through of the ultimate strength compared to the base metal specimen result. The results of Ultimate strengths appear that the specimen base metal is greater than the specimens with defects. Experimental tests were performed by base metal specimens and defected specimens of ratio a/t at different values of semi-elliptical geometry (0.2, 0.5 and 0.8).

The results of ultimate strength measured for the different defects of semi-elliptical through the ratios a/t were: 0.2 for 488 MPa, 0.5 for 331 MPa and 0.8 for 160 MPa. In summary, in order to investigate the effect of defects, the presence of semi-elliptical defect reduces the mechanical characteristics especially at the ratio $a/t=0.8$. Depending on the ultimate strength the maximum value of the ultimate stress of the defect at the ratio $a/t = 0.2$ almost conforms to API 5L standard and as mentioned above. Thus the results of ultimate strength of $a/t = 0.2$ and $a/t = 0.5$ can explain that the variation of the depth shape (a) for semi-elliptical geometry has great effect on the behavior of defects and security of piping systems [14-16].

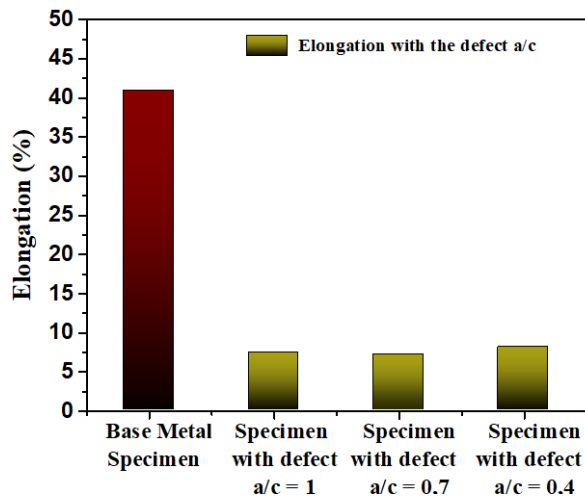
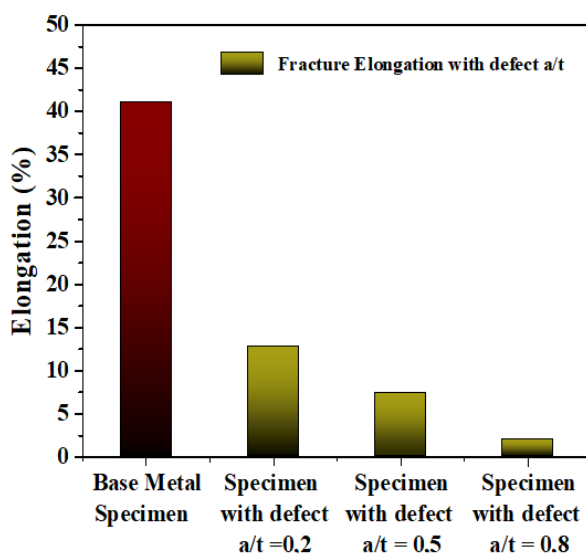
Based on the experimental results of the elongation of metal with/without defects to study the resistance of material, the Figures 16 and 18 show that the tensile tests of the defected specimen by semi-elliptical forms where the ratio a/c lost almost the average of 80% and the ratio a/t lost from 67% to 95% compared to base metal. Depending on the obtained experimental results in order to understand this phenomenon, the effect for different ratios a/c and a/t for the semi-elliptical defect on the safety of piping systems are important factors to analyze the behavior of crack and security of transport systems. The experimental results of elongation show the variations of effect of ratio a/c and ratio a/t on the defects phenomenon, where the percentage of semi-elliptical for the ratios a/c varied from 7.36% to 7.9% which are considered as a simple change. However, the high difference of elongation according to the variation of the ratios (a/t) indicates to effect of defect on the mechanical characteristics by percentages from 12.36% up to 1.98%. It is interesting to mention that the experimental results, for considered phenomenon explained the behavior of defects of semi-elliptical through ratios a/c and a/t , which effect on the size of defects. In view of the experimental results, the values which highly percentages were accepted where the ratios $a/c=1$ and $a/c=0.7$ gave the elongation values of 25.36% and 24.36% respectively. The same for the ratios $a/t=0.2$ and $a/t=0.5$ gave the elongation values of 36.36% and 24.36% respectively. From the values obtained in the Figures 17 and 19 show that the repaired specimens showed the improve in the elongation results, thus it explains the develop of the mechanical characteristics according on the accepted elongation value which is greater than 24% depending on the standard required. In order to find accurately solutions and sufficient, the values of ratios $a/c=0.4$ and $a/t=0.8$ are not agree with the API 5L standard to keep the mechanical characteristics.

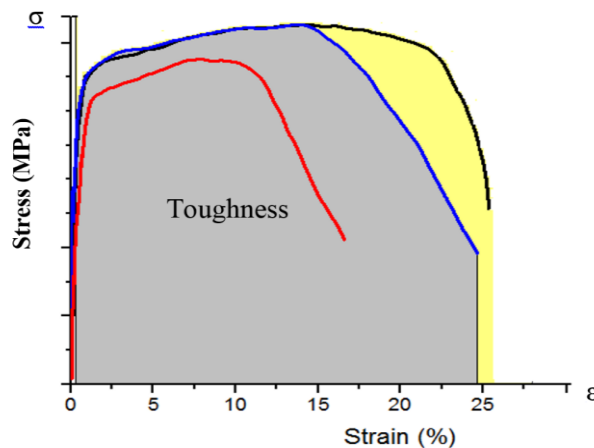
Figure 20. Toughness is by calculating the areas under the stress-strain curves

In order to measure the toughness factor which was applied to the critical sections of pipeline to estimate the absorb energy and plastically deform without fracturing. Toughness can be calculated by integrating the stress-strain curve it is energy of mechanical deformation per unit volume prior to fracture where it based on the equation mathematical as following:

$$W = \int_0^{\epsilon} \sigma d\epsilon \tag{1}$$

where, ϵ is the strain, σ is the stress, W is the toughness, energy absorbed to fracture of material in tension.

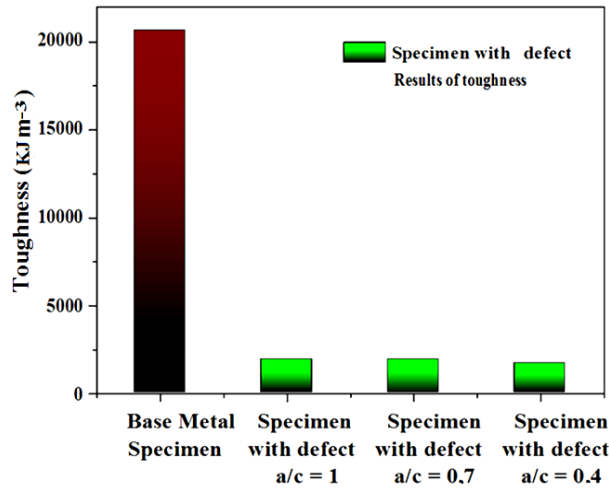
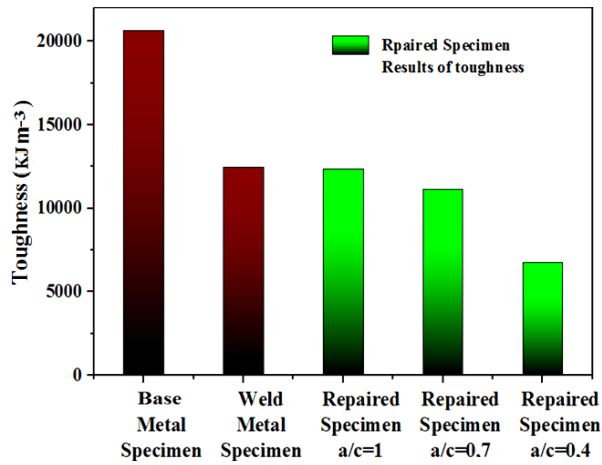
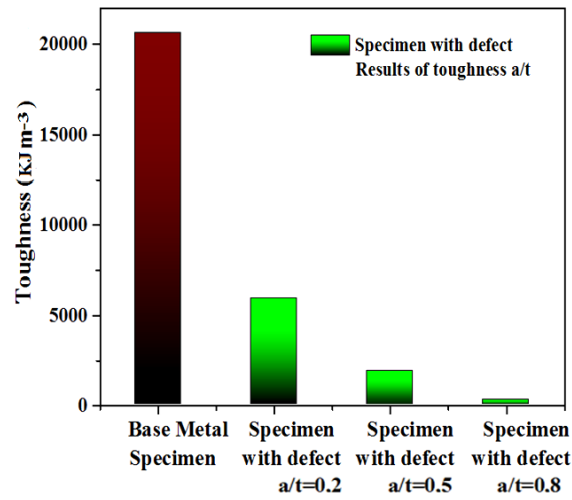
Figures 21 to 24 proved that the effects of the semi-elliptical of corrosion defect on toughness and the energy absorbed during fracture related with the mechanical properties including the nature of materials. The energy absorbed is become important factor to measure the capacity of material where it is calculated by the integration of the areas under the stress-strain curves through per unit volume. Figures 21 and 23 compare the toughness results of specimens with/without defects which is based on two ratios (a/c , a/t), where the maximum values of toughness and the energy absorbed of defect $a/c = 1$ and $a/t = 0.2$ are $1895.72 \text{ kJ m}^{-3}$ and 5912.10 kJm^{-3} respectively. As it is observed that the defected specimen can propagate very low energy where it can't occur any bruit during internal rupture (slamming). Contrary, the test specimen of base metal features to propagate high internal energy which is reached to value of $20646.47 \text{ kJ m}^{-3}$ and the same of ratio $a/t = 0.2$ proved better toughness results for the repaired specimen where the value of this operation reached to $17729.03 \text{ kJ m}^{-3}$.

In addition, this solution proves that the corrosion of semi-elliptical defect in the depth is more dangerous than the defect length and its repair less efficient in API X52 pipe, where the value of ratio $a/t = 0.8$ is the lowest value which is reached to 274.59 kJ m^{-3} . Figures 22 and 24 have shown that the ratios a/c and a/t of toughness of tensile are important to show the impact of defect of semi-elliptical along the piping systems such as the refinery stations, elbows and welded zones, where the maximum value of the toughness for the repaired specimen at the ratio $a/c = 1$ is approximately equal to the toughness of the automatically welded specimen. The welding operation is one of among an important solutions to avoid the crack phenomenon which are occurred under the external/ internal stresses concentration effects, the bending load and the manufacturing defects, where these reasons can influence on the safety of piping systems [5, 49-57].
